marantz® SERVICE BULLETIN		Date: 15-May-2003	Model SR7300
		Page: 1/1	REF.NBR: MZ03-003
Circulation:		Subject:	
Application:		Broken Knob	
x for information customer complaint in case of service mandatory		Int.ref:	
MZxxxxx01xxxx to MZxxxxx13xxxx

marantz® SERVICE BULLETIN		Date: 15-May-2003	Model SR7300
		Page: 1/2	REF.NBR: MZ03-006
Circulation:		Subject:	
Application:		Improvement of high tone noise	
x for information customer complaint in case of service mandatory		Int.ref:	
ALL

marantz® SERVICE BULLETIN		Date: 15-May.-2003	Model: SR7300,SR6300
		Page: 1 / 1	REF.NBR: MZ03-018
Circulation:		Application:	
x for information customer complaint in case of service mandatory		See Below	
		Subject: The problem that the remote controller can't learn other the remote controller .	
		Int.ref:

marantz® SERVICE BULLETIN		Date: 28-Sep-2003	Model: SR7300/K1G
		Page: 1 / 1	REF.NBR: MZ03-041
Circulation:		Subject:	
Application:		The MAINS CORD changed from AC IN socket type to fixed type. (/K1G version only)	
x for information customer complaint in case of service mandatory	From MZxxxxxxx30xxxx

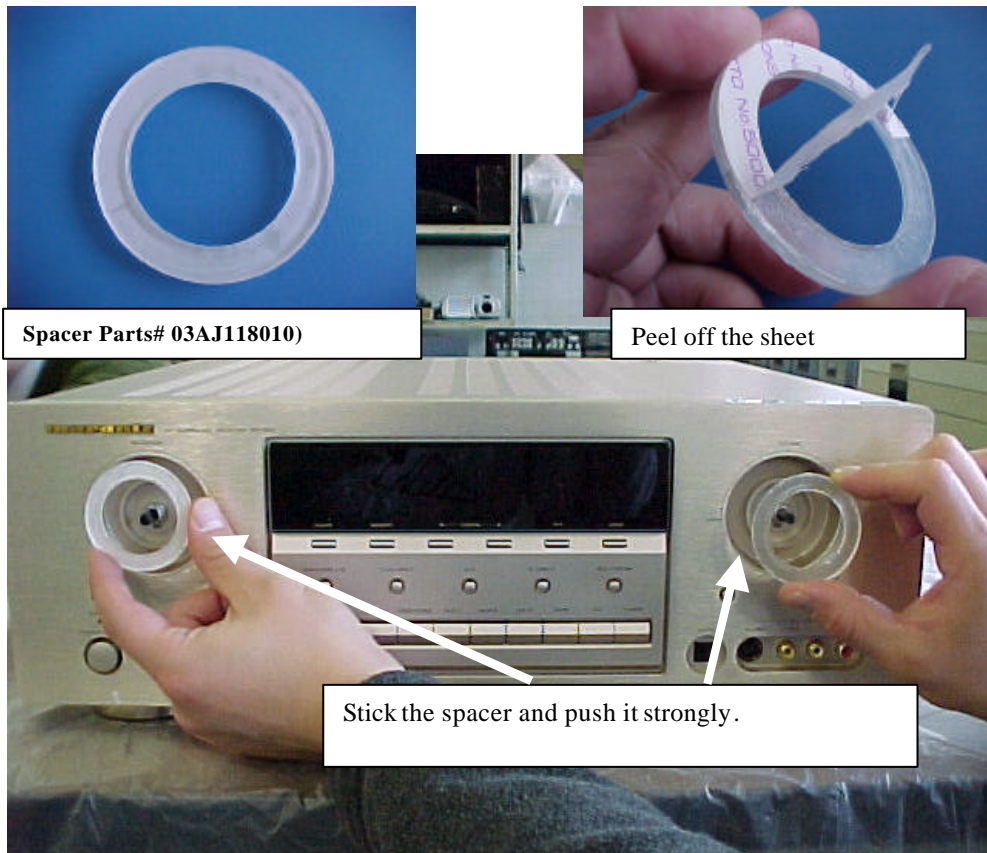
Broken Volume or Selector knob by transportation.

A clearance between the front panel and knob were a little large and get stress to the volume shaft.

Add the spacer to the front panel as follows.
(Spacer : parts No. 03AJ118010)

This improvement has been done in the production line after the LOT number "14" and later (The LOT number is "##" of serial number "MZxxxxxx##xxxx".)

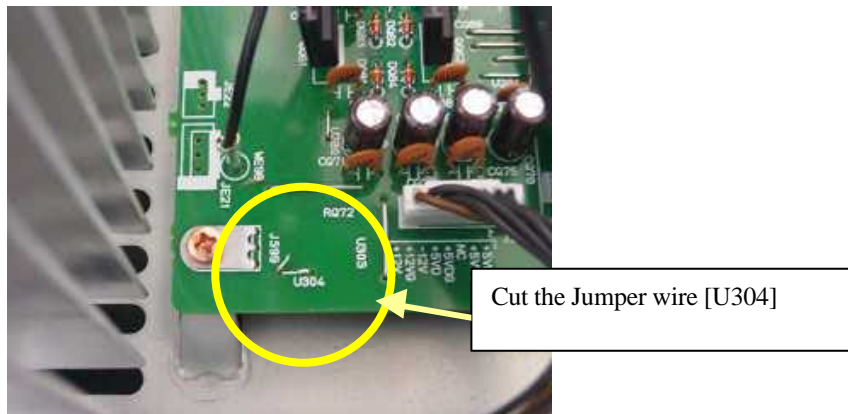
Solution 1 (For lot 01 to 15)

High tone noise can be heard a little from speaker.

- 1) Cut a jumper wire [U304] on the PS04 board.

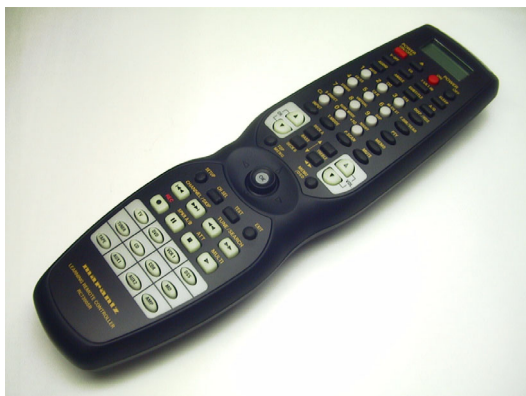
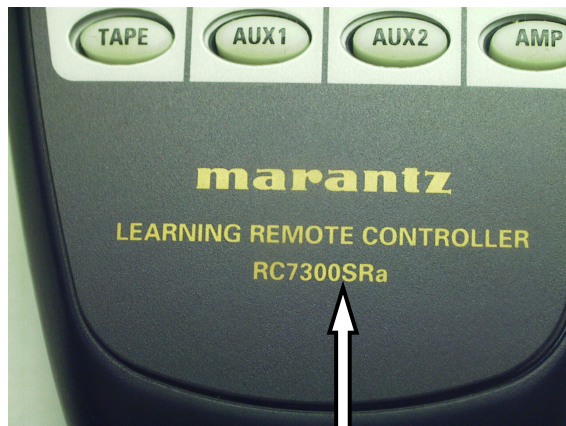
Model name RC7300SRa

When learning and memorizing the remote control codes used by Set-top Box of Time Warner Inc.,
A part of cursor button can't be learned.

RC7300SR is exchanged for the improvement the remote controller RC7300SRa.

Improvement the remote controller part no. **ZK03AJ0012**

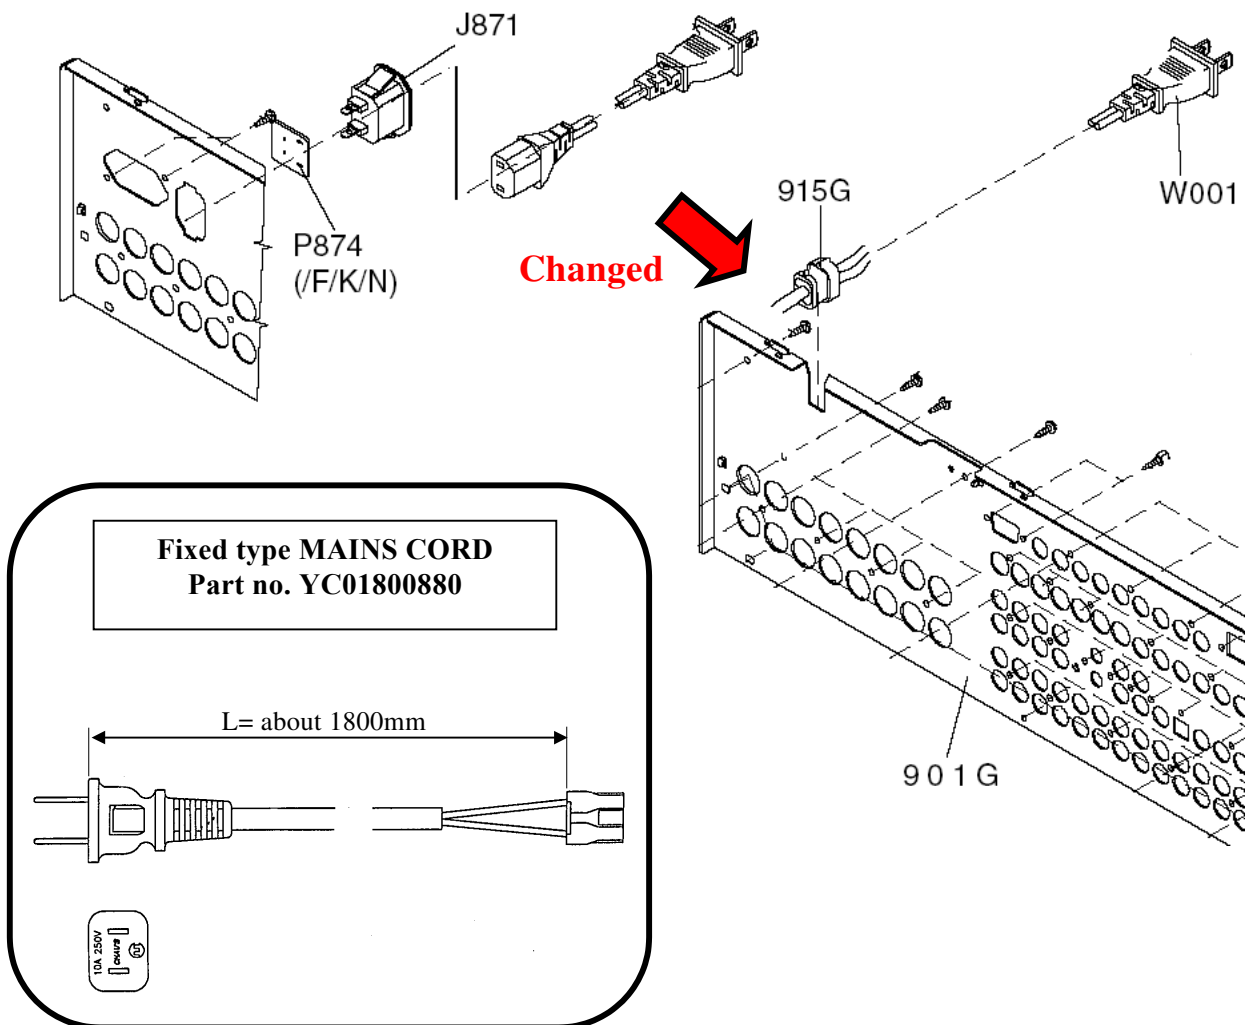
It depends on the Chinese safety standard requirement.

1. MAINS CORD is changed from (Z011) part no. ZC01803090 to (W001) part no. YC01800880 .
2. MAINS CORD BUSH (915G) part no. 450H259010 (NIFCO #2271) is added.
3. REAR PANEL (901G) is changed.(This is not supply of the service spare part)
4. AC IN socket is deleted.
