Service Bulletin

No. : MZ07-053

Model: SR7400, SR8400

Subject: Software Update

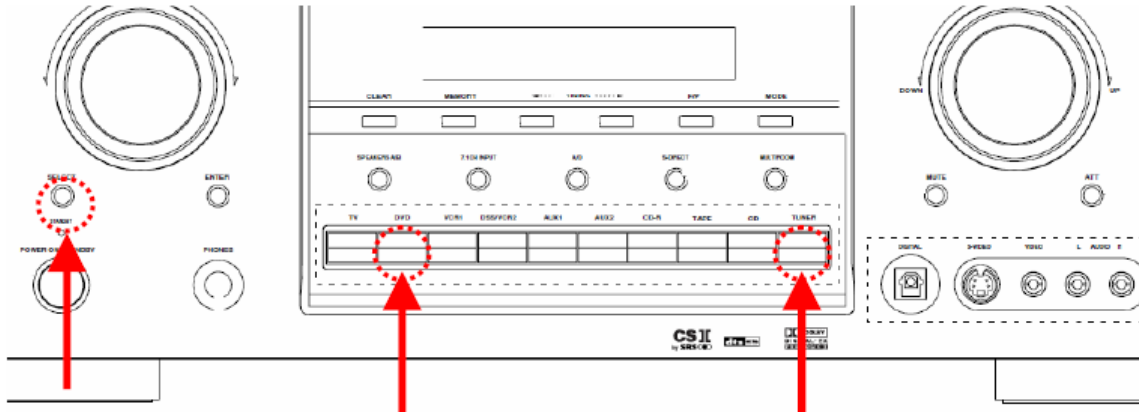
*1: If the unit cannot be powered on after being plugged in again (with the STANDBY LED flickering every 125m seconds), the power amp has failed. The unit still can be powered on again through the following method, but it can further damage the power amplifier. **Never let end-users perform this procedure.**

Can be powered on by “FACTORY KEY”=[PURE DIRECT]+[7.1 CH INPUT]+[CLEAR]
