Service Bulletin

No. : MZ07-053

Model: SR7400, SR8400

Subject: Software Update

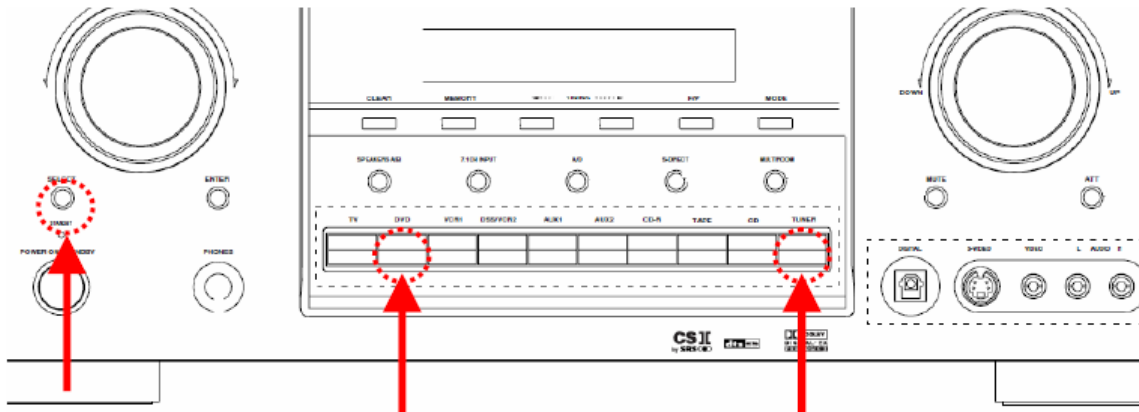
*1: If the unit cannot be powered on after being plugged in again (with the STANDBY LED flickering every 125m seconds), the power amp has failed. The unit still can be powered on again through the following method, but it can further damage the power amplifier. Never let end-users perform this procedure.

Can be powered on by “FACTORY KEY”=[PURE DIRECT]+[7.1 CH INPUT]+[CLEAR]
