Service Bulletin

No. : MZ07-052

Model: SR7500, SR8500

Subject: Software Update

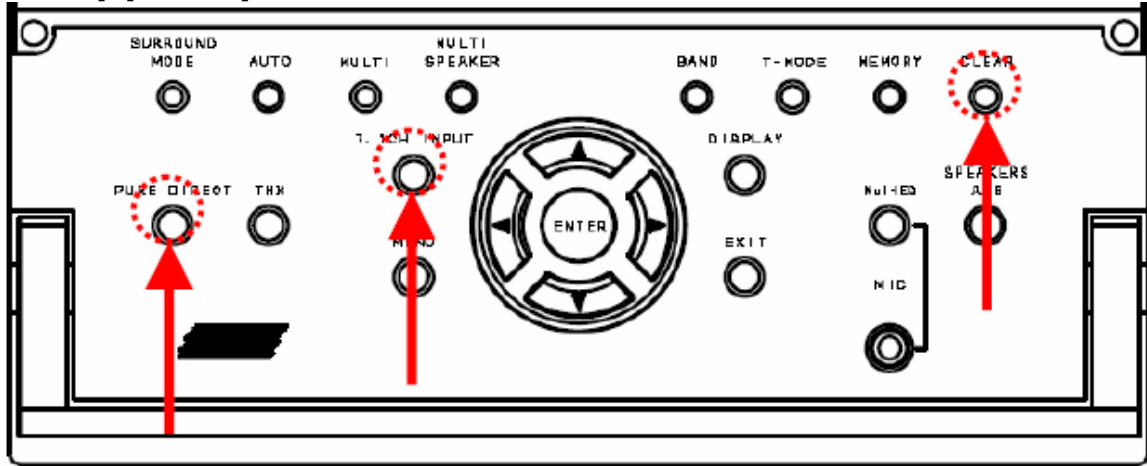
*1: If the unit cannot be powered on after being plugged in again (with the STANDBY LED flickering every 125m seconds), the power amp has failed. The unit still can be powered on again through the following method, but it can further damage the power amplifier. Never let end-users perform this procedure.

Can be powered on by “FACTORY KEY”=[PURE DIRECT]+[7.1 CH INPUT]+[CLEAR]
