Service Bulletin

No.: MZ09-125

Model: UD9004

Subject: Correction of the Video DAC.

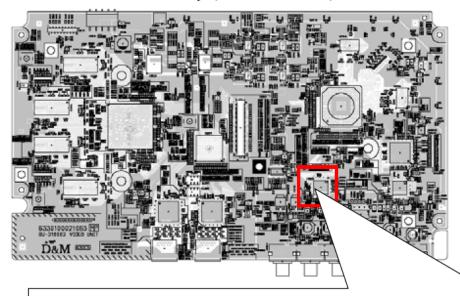
VIDEO PWB UNIT Assy (8U-310002AZ)

Symptom: The resolution of the component output is set to "1080i" and "source direct" the video setting. Then, the Pb/Cb output and the Pr/Cr output are interchanged.

Correct ("BSTZ-3" is printed)

Solution: Replace the Video DAC when the above symptom occurs and claimed by the customer.

- 1) Remove the "VIDEO PWB UNIT Assy (8U-310002AZ)". (Regarding DISASSEMBLY the unit, please refer the Page 5 of the Service Manual.)
- 2) Confirm the printed character on IC802 (Video DAC), check whether incorrect part is attached or correct part is attached on the VIDEO PWB UNIT.
- 3) Replace the IC802 to correct part if the incorrect part is attached.
- 4) Re-assemble the unit.
- 5) Turn on the power of the unit.
- 6) Set the setting of "Component Resolution" of the "Video Setup" to "1080i". Then check whether the color of the Pb/Cb and the Pr/Cr are output correctly.
