Service Bulletin

No.: MZ10-002 **Date:** April 22, 2010

Model: UD9004

Subject: Correction of power supply circuit. (For SACD Block power supply

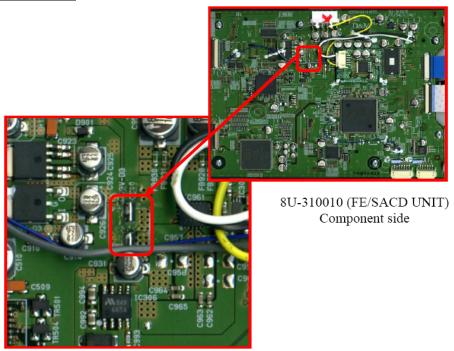
Symptom: When a SACD disc is played, "LOADING" or "NO PLAY" might be displayed.

Solution: COUNTERMEASURE: Remove C940 (Electric capacitor) located on 8U-310010 (FE/SACD UNIT). Please confirm playback of the SACD disc after removing the C940.
