Service Bulletin

No. : MZ10-004

Model: UD9004

Subject: Modification of size of screw.

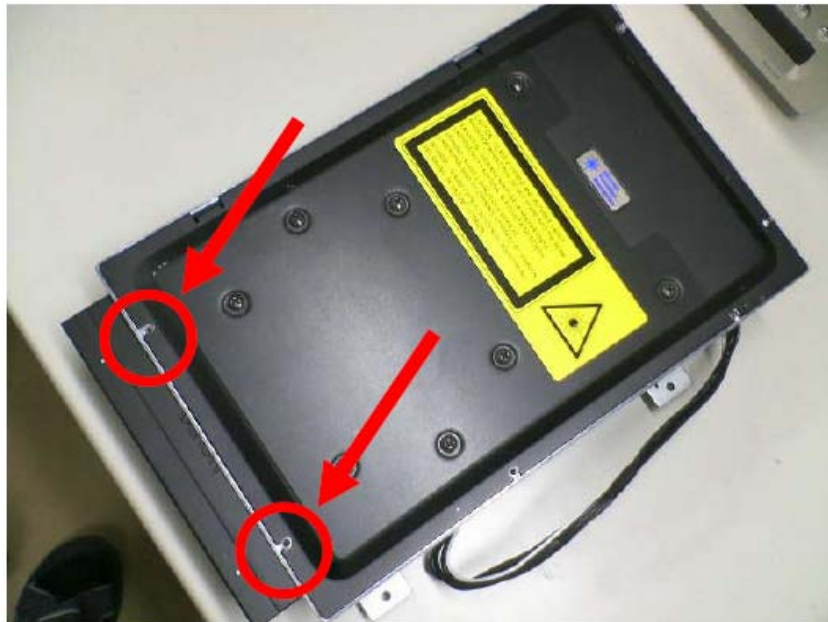
Symptom: When customers insert a disc the label side of the disc might be damaged because the screws stick out "0.4~0.7mm" from the Mechanism base.

Solution: Countermeasure: We exchanged the "2x4mm" to a "2x3mm" (2 pcs.) screw. Fixing torque: 2.0Kgf +0.2 / -0.
Before modification: 2x4mm CBS-B (Color is black)
After modification: 2x3mm CBS-Z (Color is silver)
