Technical Bulletin C320BEE

Product:Integrated AmplifierHardwareTechnical Bulletin: H2004-01

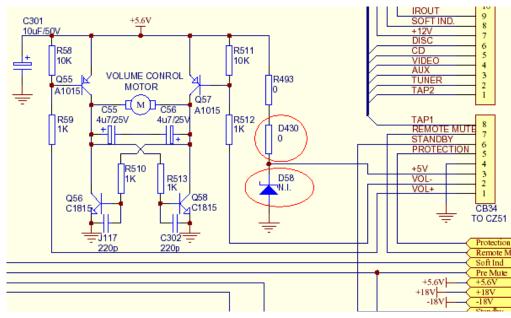
Figure 1

REASON: The volume control circuit is oscillating.

1) On the main pc board shown in figure 3, the diode D430 change from 1N4001, to a jumper link. Remove the zener diode D58 5v6 0.5W. See figure 1 for schematic change.
