Product: Integrated Amplifier
Hardware Technical Bulletin: C372-H2005-01

Date: June 1/05 Subject: Power supply capacitors

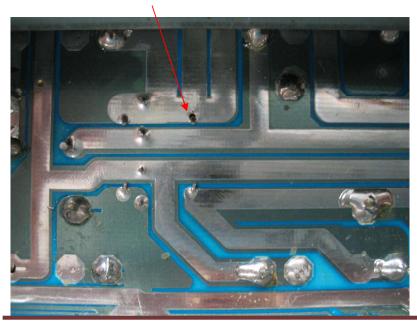
DESCRIPTION: Please perform the following modification when in for service for any reason .Power supply capacitors maybe stressed(top of caps are expanded) due to insufficient soldering on pc board trace. A very small percentage of units are affected, but severe damage is possible due to the high voltage and current in this part of the circuit.

REASON:Solder pads around jumper wires have higher than normal resistance causing power supply ripple to increase across filter capacitors. See figure 1.

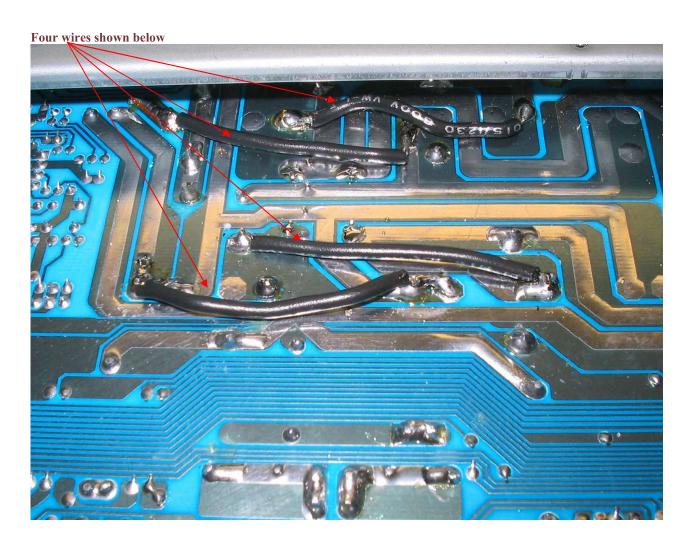
Figure 3

Addition of wires to PC Board area

SOLUTION: Add 18 gauge wires to the PCB to lower the circuit resistance. To install this modification, first remove the bottom service plate. Look for the PCB area shown in figure 2. In figure 3, the addition of black jumper wires to lower the resistance of these pc board traces is shown. Capacitors showing any signs of stress or damage should also be replaced at the same time.
