MODIFICATION

SERVICE HINT

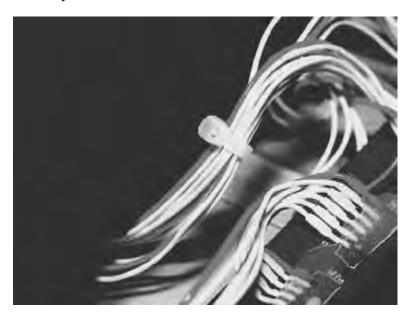
CD Player does not read disc, skips, produces scratching noise.

The cable tie that ties the two cables to the laser together scrapes over the bottom of the unit.

Relocate the cable tie as shown in the below picture, it's advisable to relocate the other cables as well to avoid any contact with the other cables.

It's advisable to perform this modification whenever a unit comes in for service.
