## Headphone circuit change

# C660 HEADPHONE SOCKET WIRING DIAGRAM

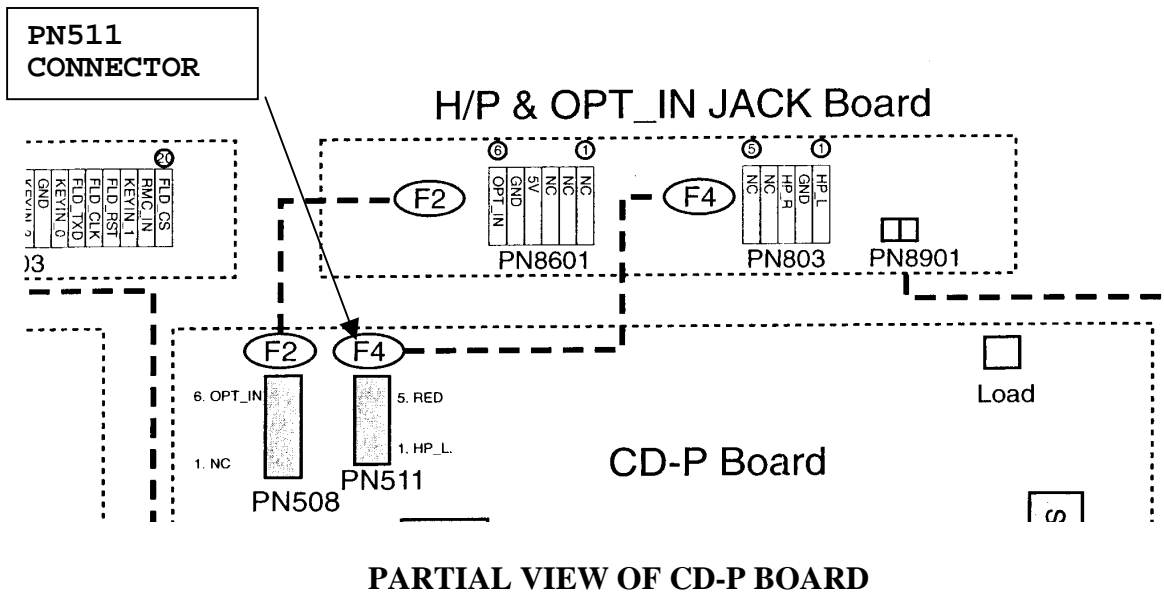
## DIAGRAM 1

*PROBLEM: Left and right channels on headphone output are reversed.*

*CAUSE: PCB traces are reversed to the headphone jack.*

*SOLUTION: Reverse left and right signal path to headphone socket .*

*Refer to Diagram 1 for modification. On the PCB for the headphone socket , connector PN511, remove the wires pin 1 (Red wire left ch.) and pin 3 (White wire right ch.) from the connector and reverse their positions when inserting wires back into connector.*
