Service Tip

Problem: Poor response of AV Receiver to remote commands.

Affected Models: Some T760, T751, T761; not all units are affected.

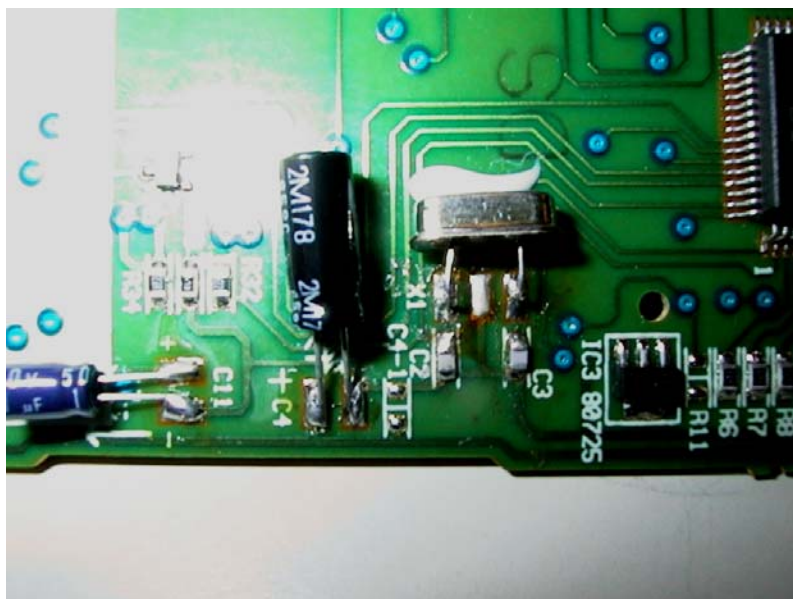
Diagram 2

Cause: Mismatch of IR frequency between Remote and Receiver.

2. With the remote opened, locate X1, C2, and C3 . X1 is a ceramic resonator type and should be replaced with a crystal 9.8304 MHz as shown in Diagram 2. Capacitors C2 and C3 are now required for proper operation. Install capacitors C2 and C3, 22pF (surface mount type 0805 series) as shown in diagram 2.
