Circuit Change

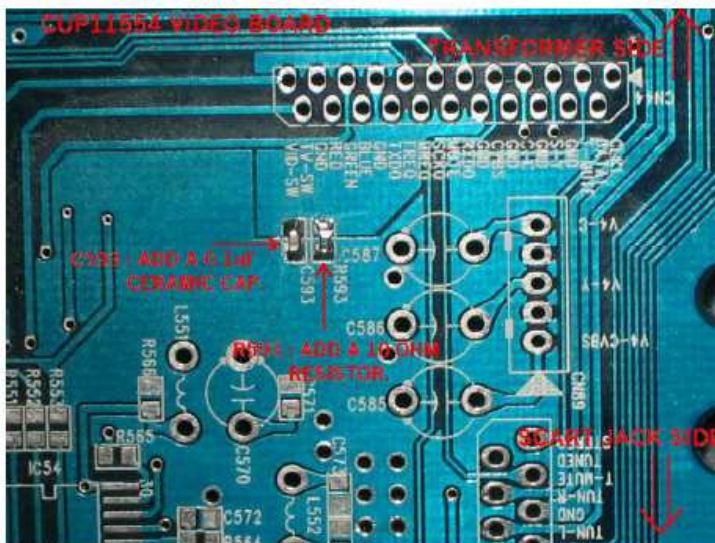
Photo 1

PROBLEM: *When using the component out on the L70 you may find the video signal has faint diagonal lines appearing.*

CAUSE: *The ground plane requires additional coupling.*

SOLUTION: *Add a 10 ohm resistor to location R593 on the video board. Add a 0.1uF ceramic capacitor to location C593 on the video board. See photo below.*
