# Service Information L70

# **Circuit Change**

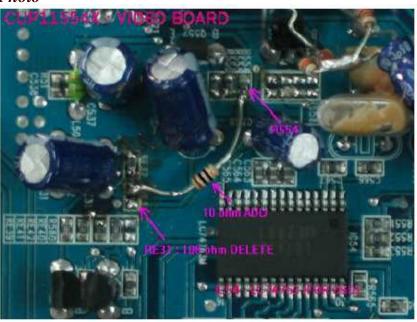
#### Photo

PROBLEM: You may have the complaint that the TV SCART RGB output is not switching automatically.

CAUSE: The drive current of some television sets is not sufficient to switch the RGB output.

Delete RE31 100 ohm resistor on video board. Add a 10 ohm resistor between PIN 16 of SCART connector (one leg of RE31) and +5V rail(one leg of R554) on video board. See photo and schematic diagram.
