# Technical Bulletin T163

**Product:** A/V Receiver

**Hardware Technical Bulletin:** T163-H2004-02

**Subject:** HDTV Component  
Video change

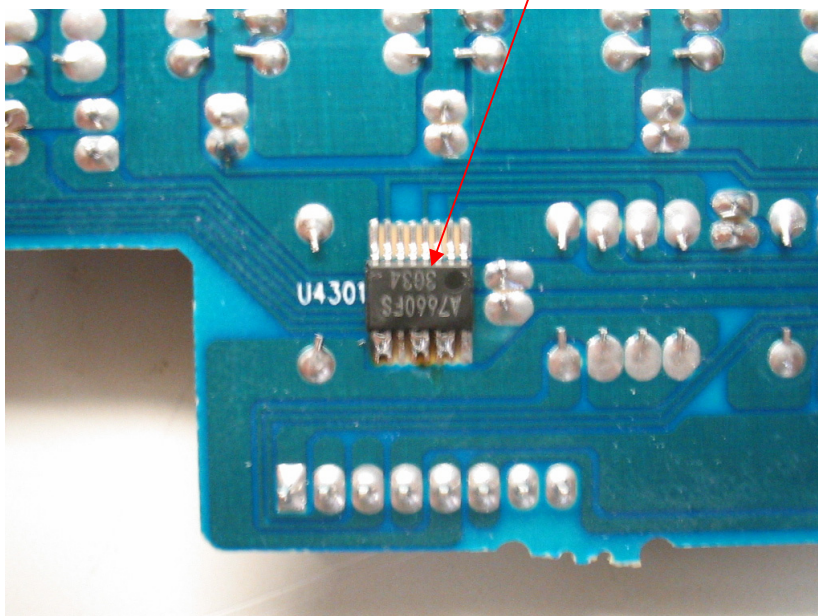
Figure1

**REASON:** When decoding HDTV signals some TV/Monitors may experience horizontal sync loss.

On the component video PCB U4301

- A) Link the following pins on U4301;
- Pins 9 to 10
  - Pins 12 to 13
  - Pins 14 to 15
