Technical Bulletin T163

Product: A/V Receiver

Hardware Technical Bulletin: T163-H2005-04

Date: February 28/05 **Subject:** Intermittantly shuts down

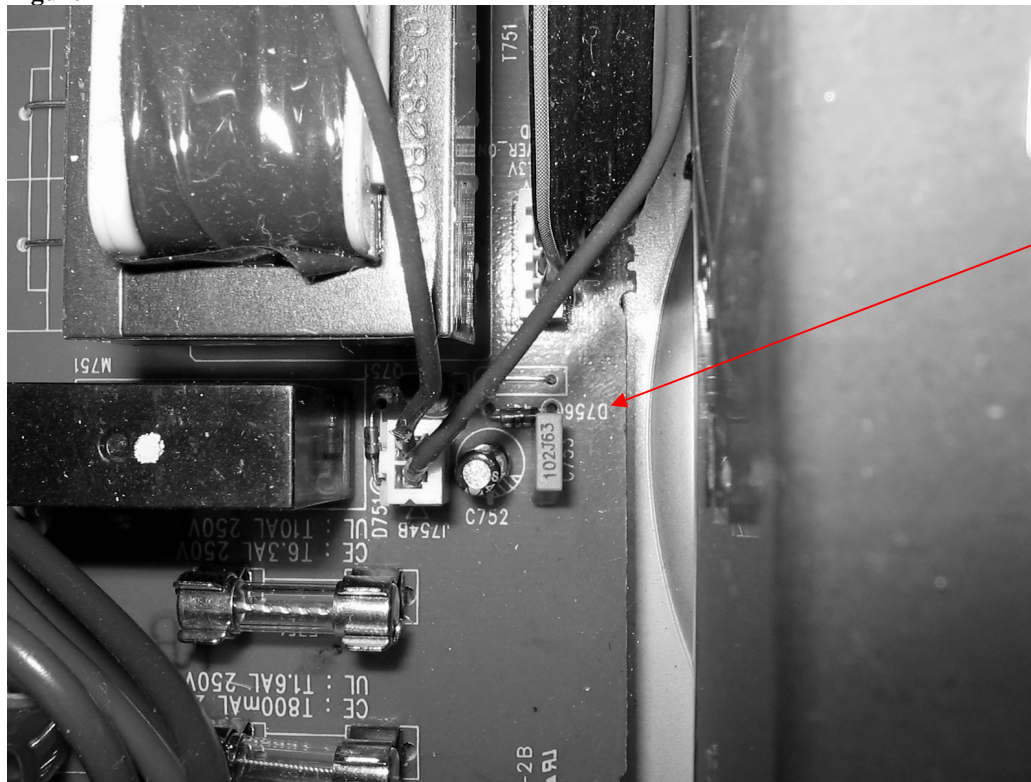
Figure 1

DESCRIPTION: Unit may shut down, shortly after turn on.

REASON: There is a diode on the standby board that maybe operating intermittantly.

SOLUTION: Locate and identify D756 on the standby board. Change only if the diode is a 1N4148. Change from a 1N4148 to a 1N4004 or equivalent. See figure 1 for details.

D756
CHANGE
FROM
1N4148 TO
1N4004
