Technical Bulletin T562

Product: DVD Player

Hardware Technical Bulletin: H2004-01

Subject: POPPING NOISE

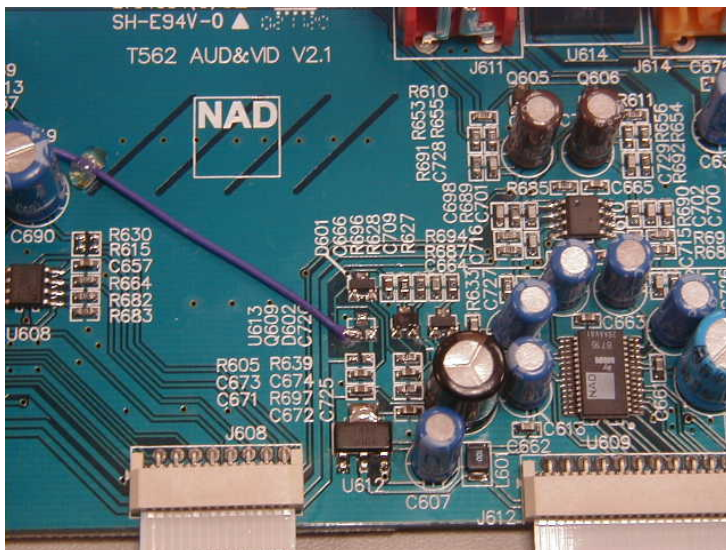
DESCRIPTION: You may have a complaint that when turning the unit on from the front panel, a pop noise is heard from the analogue audio output.

REASON: The muting circuit is not activating during the first 1/4 second of operation.

For VER. 2.1 remove U613 and R605, located near the right side of the video socket J608, as shown in Figure 1.

For VER 2.0 remove only U613, located near the right side of the video socket J608, as shown in Figure 1.

Solder a wire from U613's pin 1 (solder pad closest to J608) to Q501's emitter leg as shown in Figure 1 and Figure 2.
