Technical Bulletin

T743

Hardware Technical Bulletin: T743-H2004-02

Date: June 15, 2004 Subject: Flat Ribbon Cables

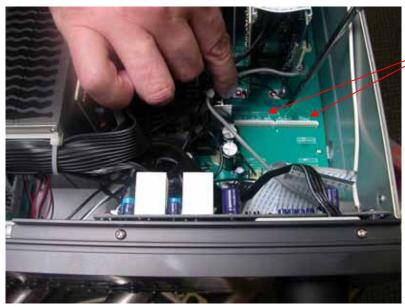
Figure 2

Ribbon cables are easily unplugged from these connectors.
