Technical Bulletin T743

Product: A/V Receiver

Hardware Technical Bulletin: T743-H2004-03

Subject: HDTV Component
Video change

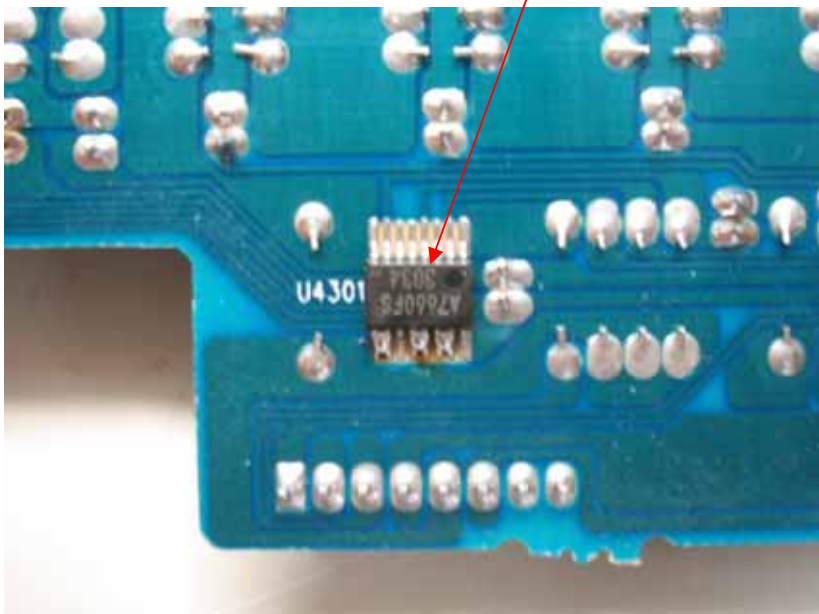
Figure1

REASON: When decoding HDTV signals some TV/Monitors may experience horizontal sync loss.

- A) Link the following pins on U4301;
- Pins 9 to 10
 - Pins 12 to 13
 - Pins 14 to 15
