Technical Bulletin T743

Product: A/V Receiver

Hardware Technical Bulletin: T743-H2005-06

Date: February 28/05 **Subject:** Intermittantly shuts down
Note: Implemented in production from serial number:R44T74306601

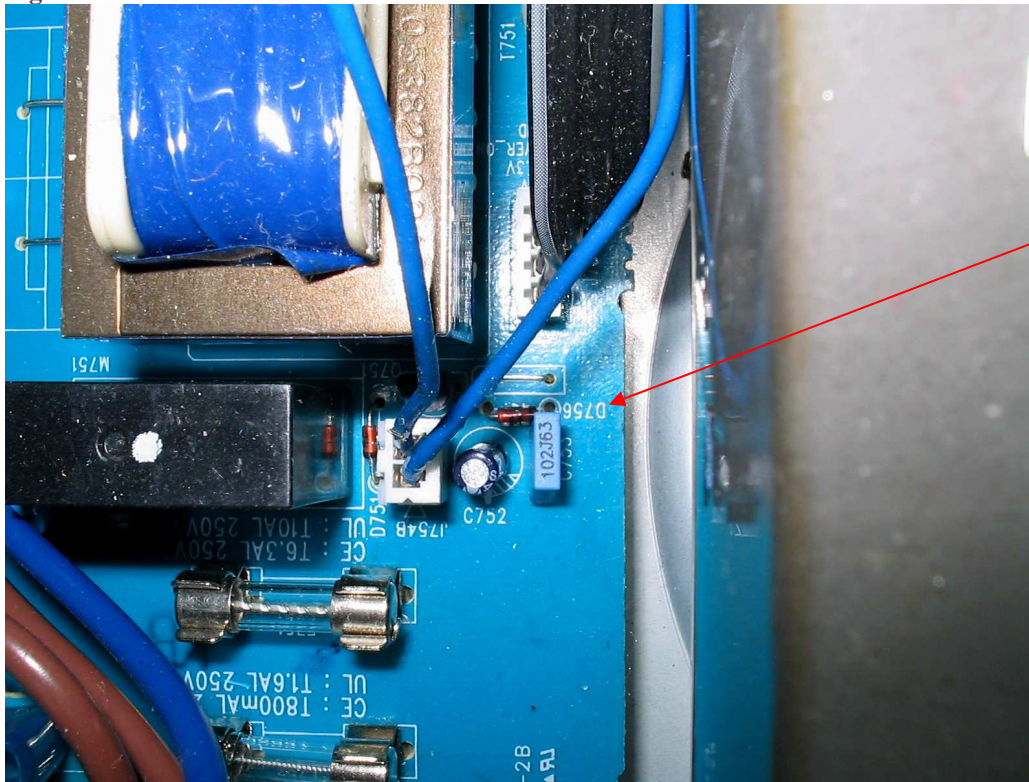
Figure 1

DESCRIPTION: Unit may shut down, shortly after turn on.

REASON: There is a diode on the standby board that maybe operating intermittantly.

SOLUTION: Locate and identify D756 on the standby board. Change only if the diode is a 1N4148. Change from a 1N4148 to a 1N4004 or equivalent. See figure 1 for details.

D756
CHANGE
FROM
1N4148 TO
1N4004
