## Muting circuit change

**PROBLEM:** Popping noise at pre out and speaker out during turn on and off.

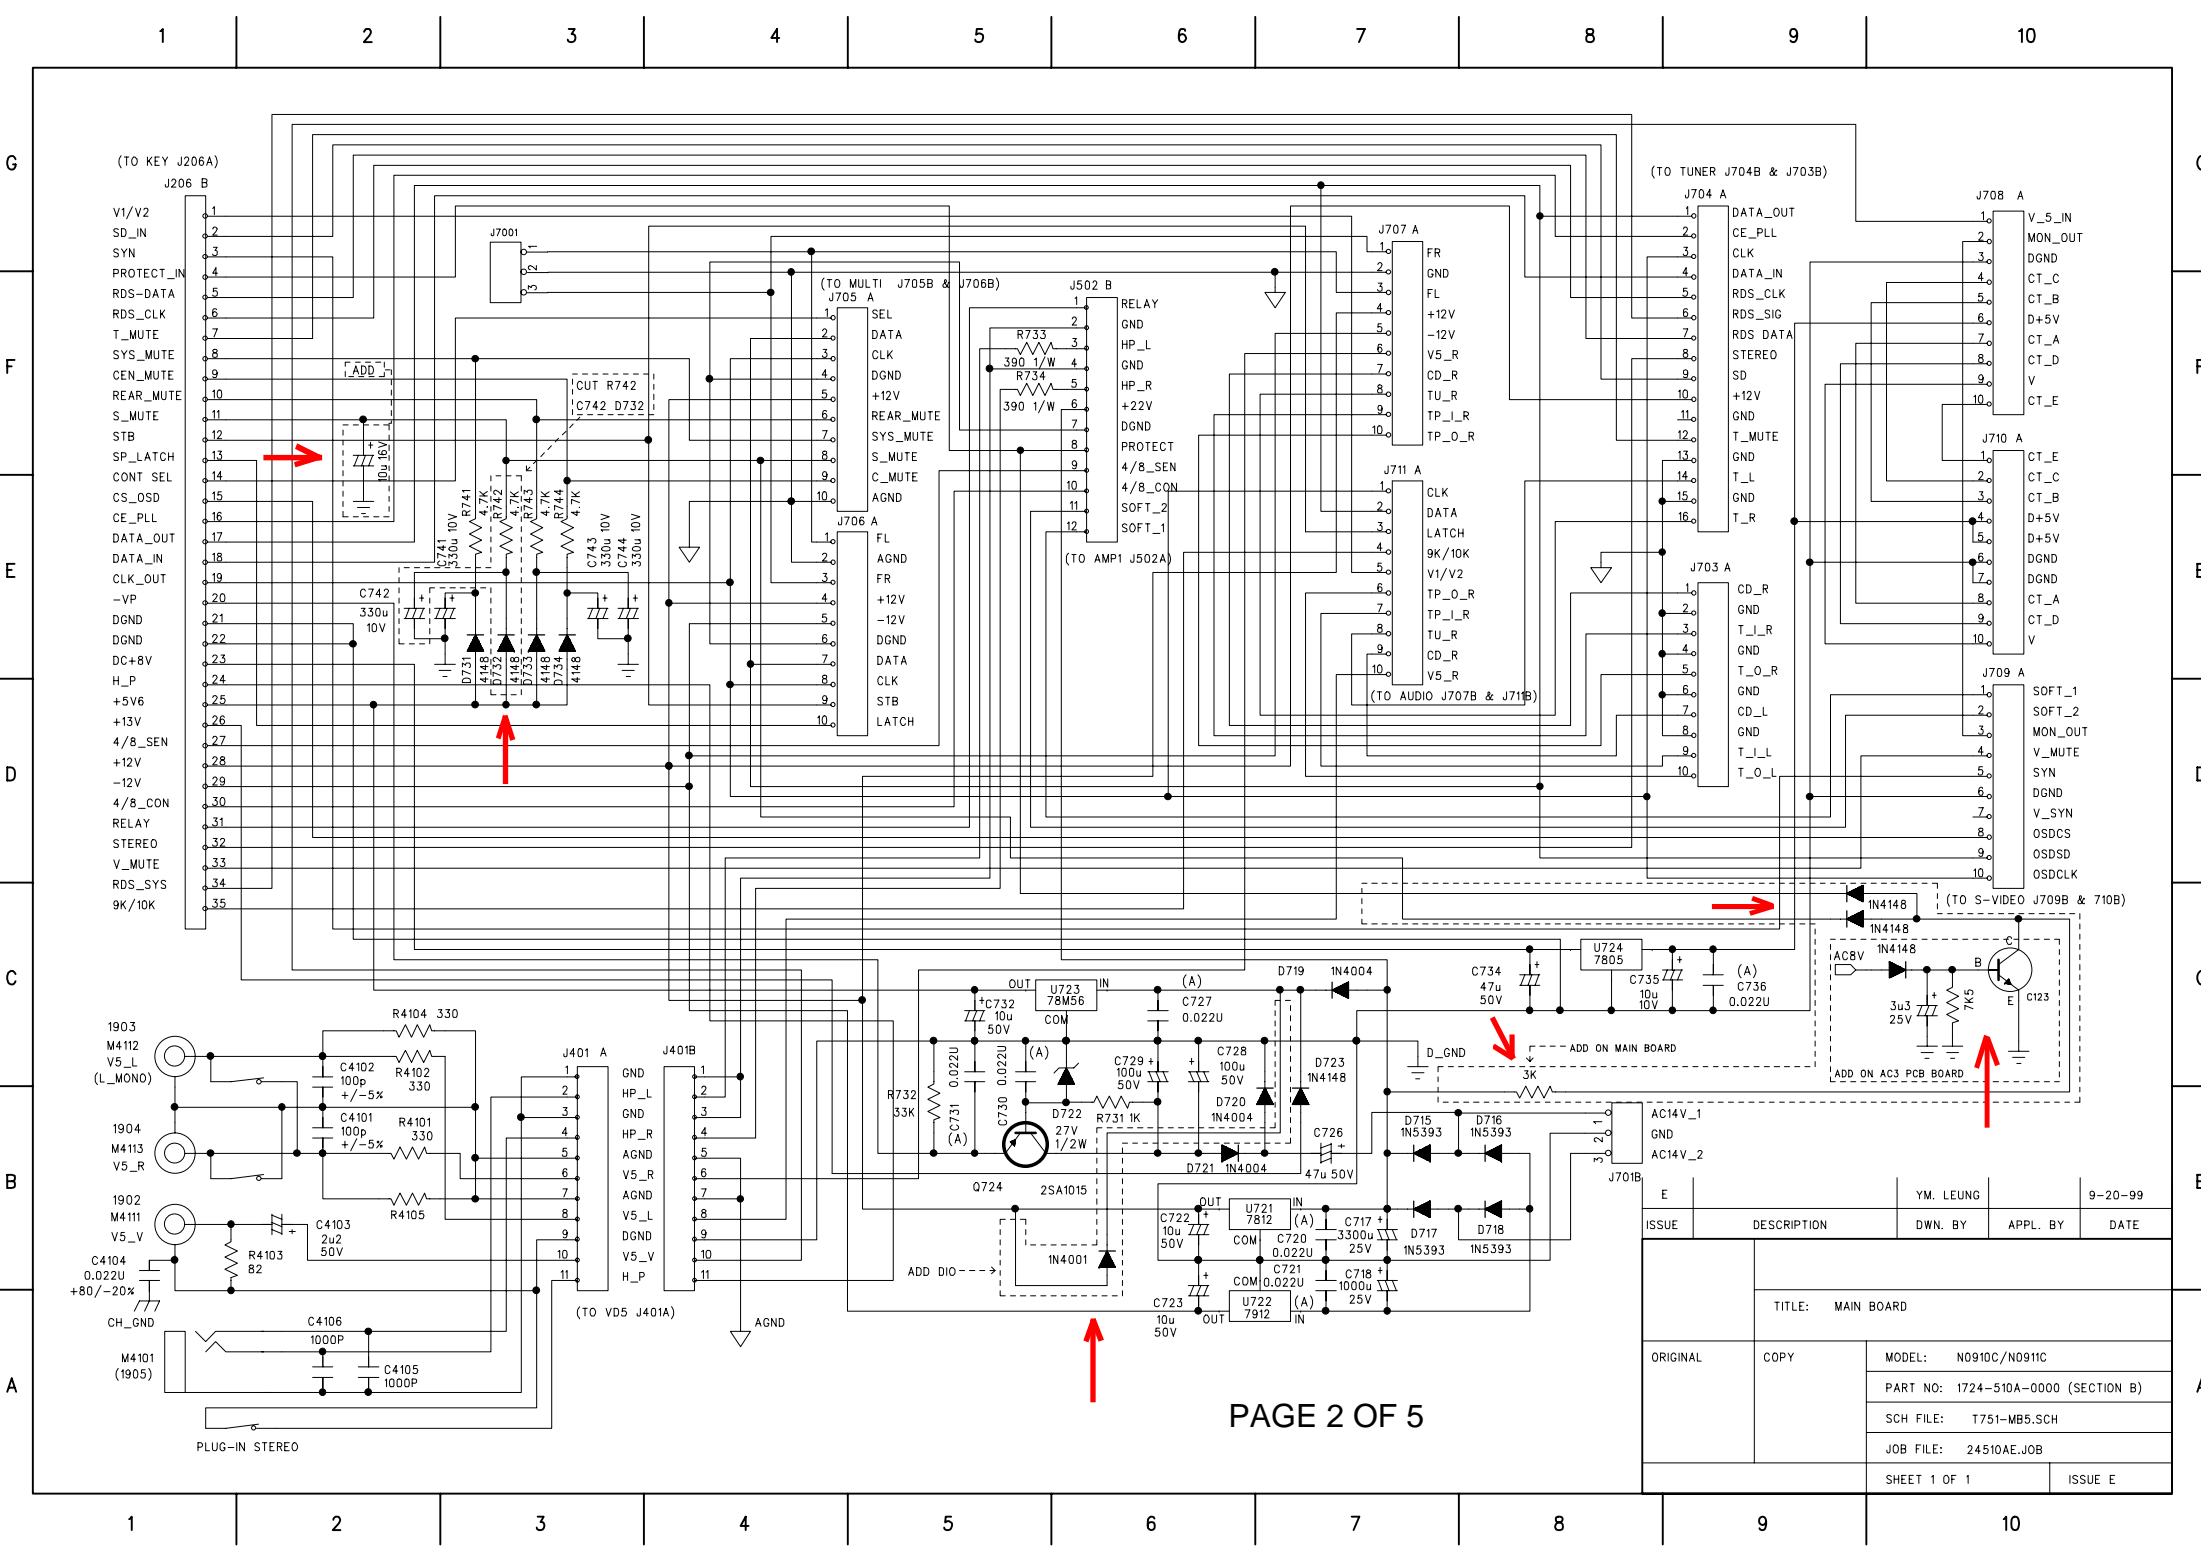
**CAUSE:** Muting circuits response is slow.

**SECTION B - MAIN BOARD**

1. DELETE R742(4K7) D732 (1N4148) AND C742 (330Uf/10v)
2. ADD 2 PCS OF 1N4148 DIODE .
3. ADD 10uF /16V ELECTROLYTIC CAPACITOR
4. ADD 3K 1/8W RESISTOR
5. ADD 1N4001 DIODE
