Technical Bulletin T753

Product: A/V Receiver

Hardware Technical Bulletin: T753-H2004-03

Subject: HDTV Component
Video change

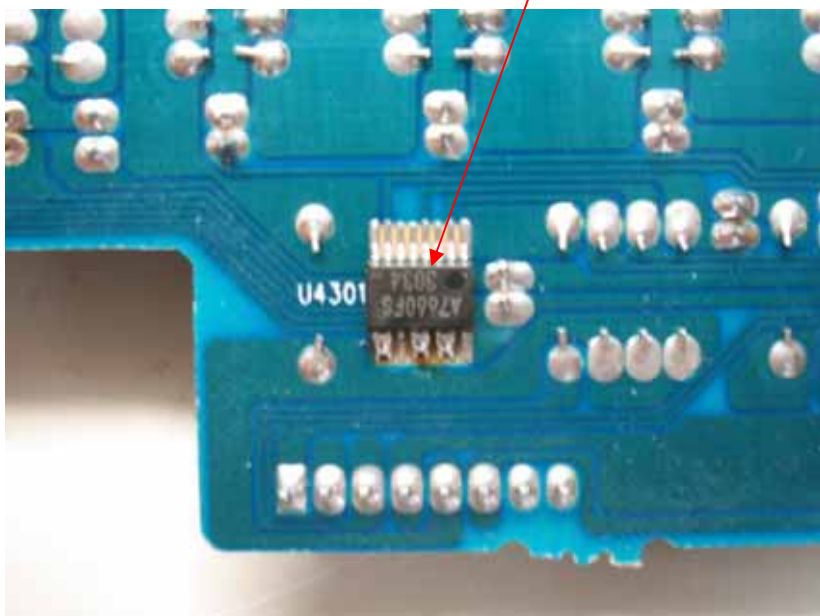
Figure1

REASON: When decoding HDTV signals some TV/Monitors may experience horizontal sync loss.

- A) Link the following pins on U4301;
- Pins 9 to 10
 - Pins 12 to 13
 - Pins 14 to 15
