MODIFICATION

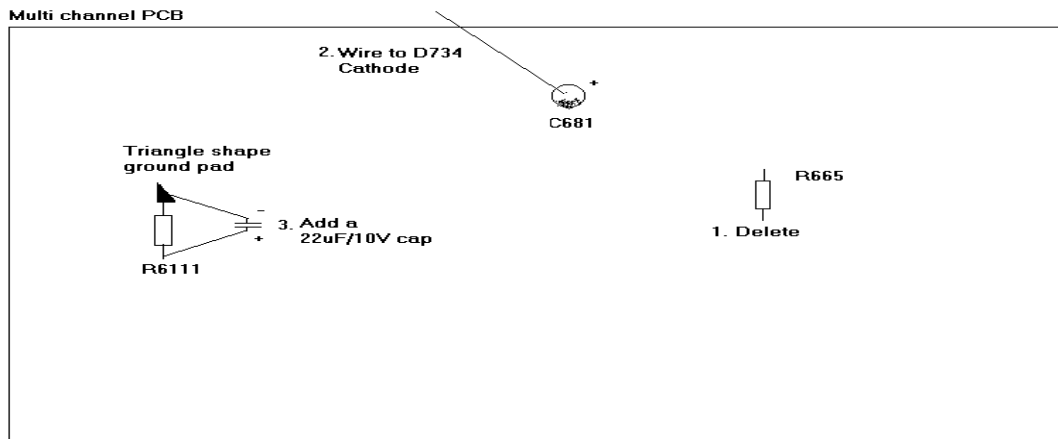
Sometimes when turning the unit on or off there will be a pop on the subwoofer pre-out

The muting of the subwoofer preamp comes in too late

The following changes, unless otherwise specified, need to be preformed on the multi channel PCB.
Please refer to attached diagram.

1. Remove R665
2. Add a wire between C681 positive pole & D734 cathode side (D734 is located on the main board)
3. Add a 22uF / 10V ce Capacitor over R6111, the negative pole needs to face up.
