## **Circuit Change (Revised)**

**NAD Electronics International**

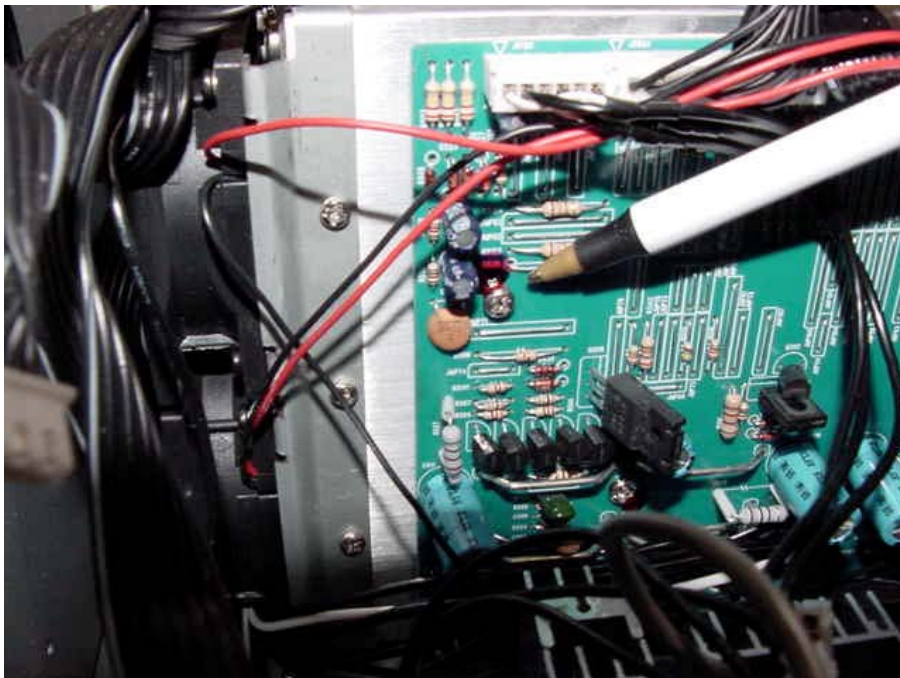
**PROBLEM:** *You may have the complaint, receiver turns on and the front panel display shows the message “OVERHEAT”.*

**CAUSE:** *A screw on the power amplifier circuit board is loose causing a poor ground and triggering a false “overheat” condition.*

**SOLUTION:** PART A:

*Looking from the front of the unit, locate and tighten the screw on the amplifier board which is on the right hand side of the power amp module.*
