Technical Bulletin T763

Product: A/V Receiver

Hardware Technical Bulletin: T763-H2004-03

Subject: HDTV Component
Video change

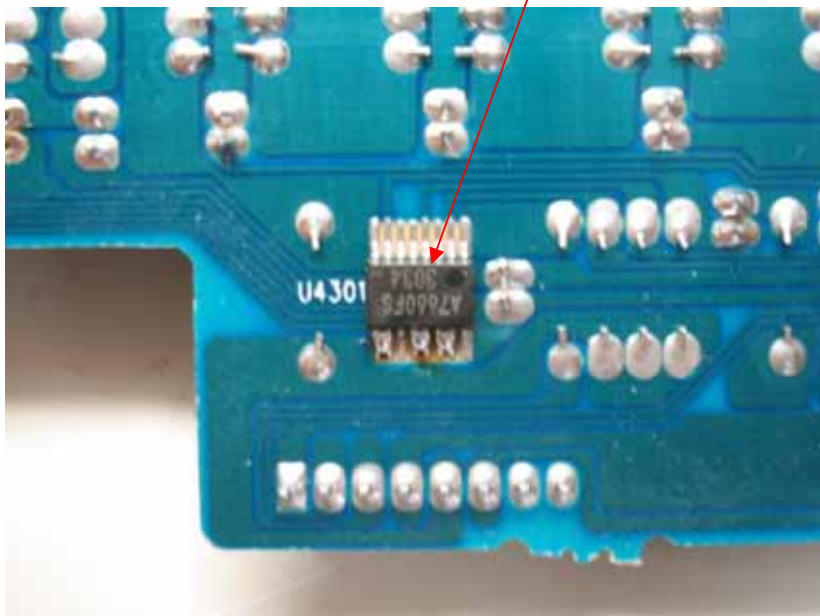
Figure1

REASON: When decoding HDTV signals some TV/Monitors may experience horizontal sync loss.

On the component video PCB U4301

- A) Link the following pins on U4301;
- Pins 9 to 10
 - Pins 12 to 13
 - Pins 14 to 15
