Technical Bulletin T773

Product: A/V Receiver

Hardware Technical Bulletin: H2004-01

Subject: DSP WHITE NOISE

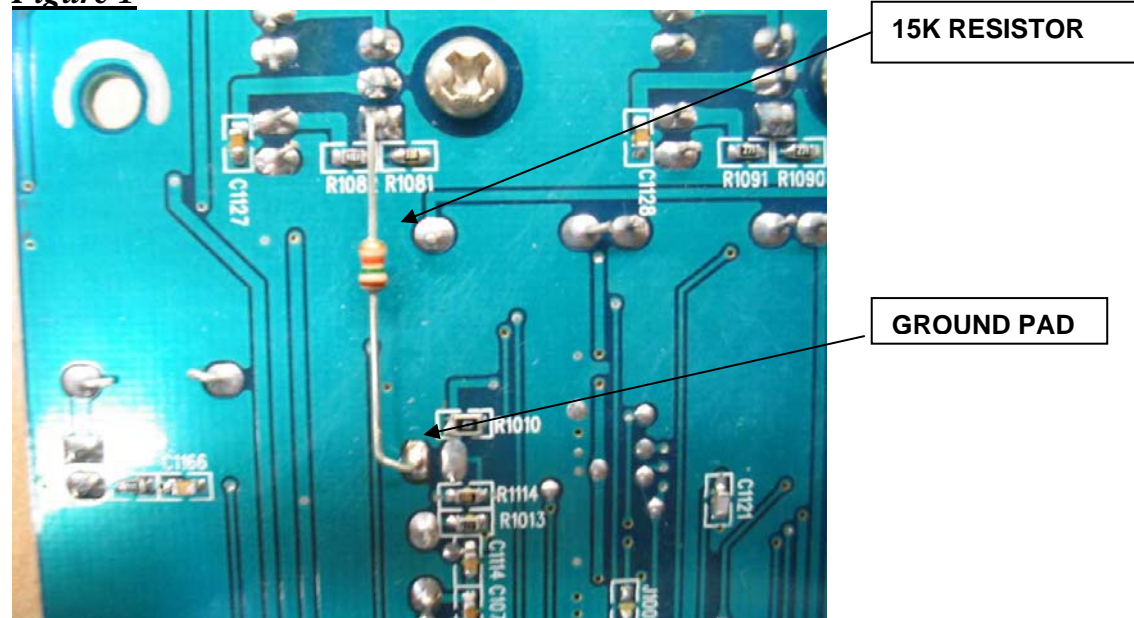
DESCRIPTION: During a playback from a digital surround source you may find a white noise sound coming from one or more speakers during the first few minutes after turn on.

REASON: The voltage regulator on the dsp board is running just above nominal rating causing the DSP board I.C.'s to produce white noise when first turned on.

SOLUTION: The resistor R1081 needs to be changed to a lower value, from 3.3K ohm to 2.7k ohm. To do this it is not recommended to remove the resistor as it is a surface mount type. Instead a 15K ohm resistor 1/8W can be placed in parallel with the 3.3K ohm resistor to give an overall value of 2.7K ohm. Location is between pin 1 of U1015 and ground. See Figure 1 for reference.
