Technical Bulletin

T773

Product: A/V Receivers
Hardware Technical Bulletin: T773-H2004-03

Date: June 15, 2004 Subject: Flat Ribbon Cables

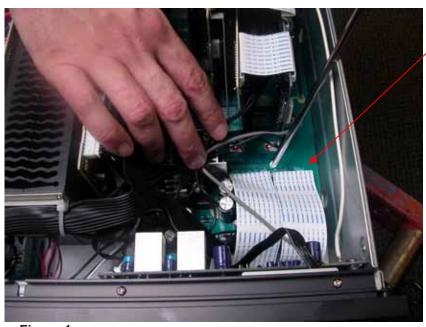
Figure 1

Locate and remove the ribbon cables, front panel cables shown.

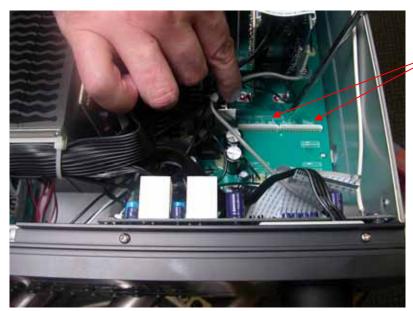
Figure 2

Ribbon cables are easily unplugged from these connectors.
