Technical Bulletin T773

Product: A/V Receiver

Hardware Technical Bulletin: T773-H2005-05

Date: February 28/05 Subject: Intermittantly shuts down

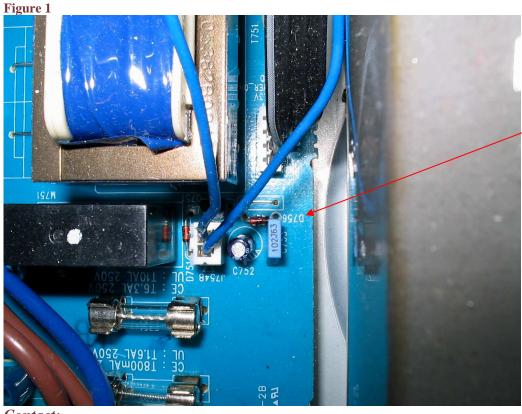
DESCRIPTION: Unit may shut down, shortly after turn on.

REASON: There is a diode on the standby board that maybe operating intermittantly.

D756 CHANGE FROM 1N4148 TO 1N4004

SOLUTION: Locate and identify D756 on the standby board. Change only if the diode is a 1N4148. Change from a 1N4148 to a 1N4004 or equivalent. See figure 1 for details.
