# Nikko Audio

## SERVICE!! BULLETIN

### MODIFICATION FOR THE ALPHA II AMP. EFFECTIVE

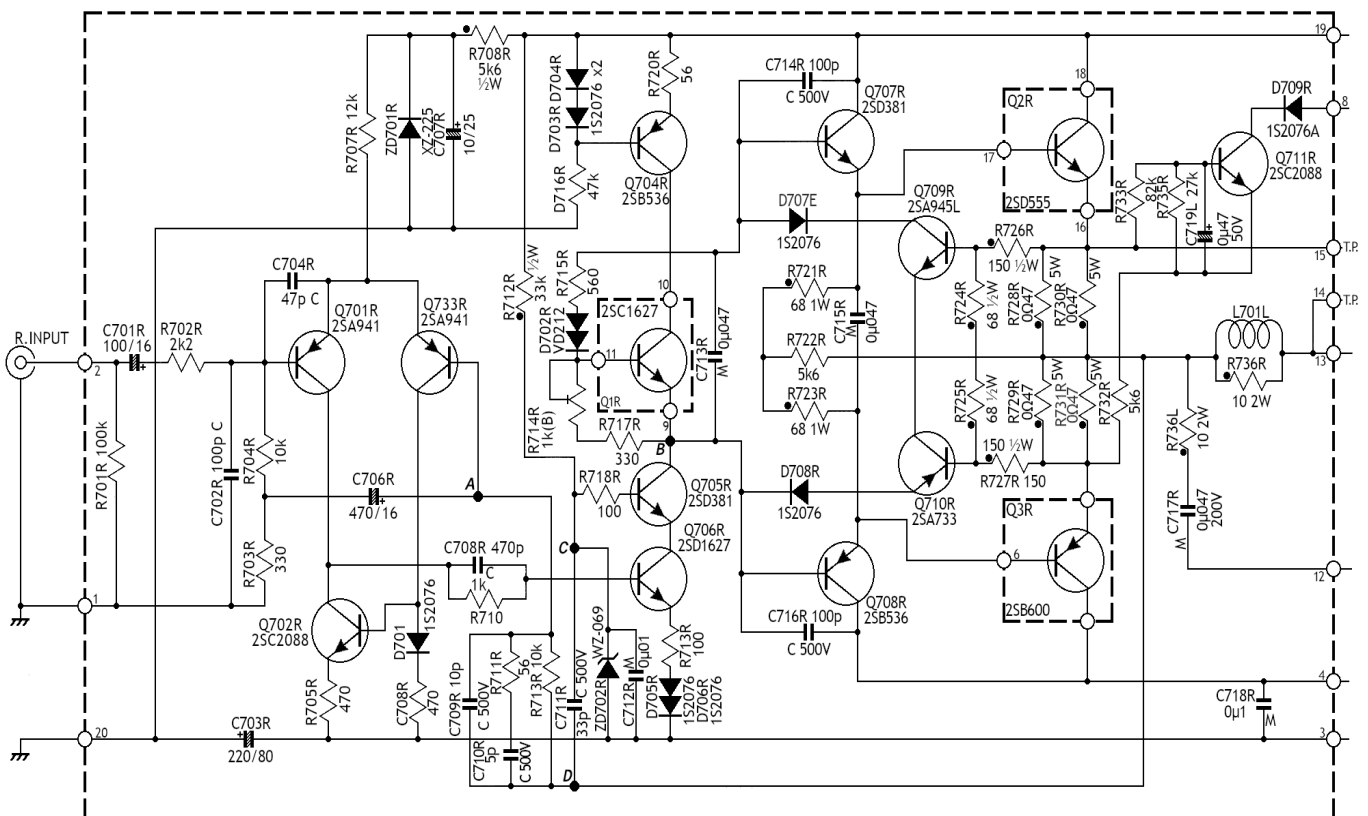
1. Disconnect (cut) positions C710 and C709 from the circuit.
2. Add 5pfd cap. between test points A and B (see diagram),
3. If C711 is valued at 33 pfd, add one more 33pfd cap.  
in parallel with C711, (test points C and D.)  
another version (replacement of 56ohm res.) of diagram  
follows on the second page of this bulletin.

- Connect 5pfd cap. to test points A and B
- Connect 33pfd cap. to points C and D

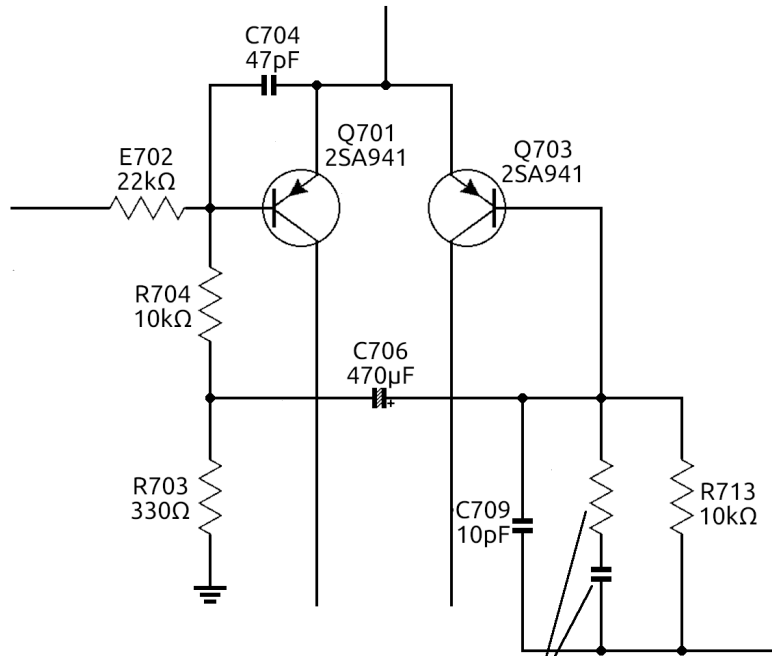
SCHEMATIC DIAGRAM

R711 56Ω  
C710 5pF disconnect these
