Service Bulletin

No. 012

Model: CDC-3/3.1/3.4, DX-C34/C370/C380/C390

Subject: Alignment Tips before Replacing the KSS-213C Optical Pickup.

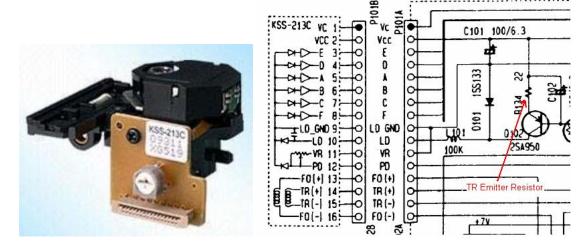
Solution: Measure IP of Pickup at both ends of TR Emitter Resistor (20-30 ohm) connected to LD terminal of Pickup, and then compare the measured value with the standard value (printed on label).

1.) IP (laser current) Check

If the obtained IP value is lower than the standard value perform the following:

Note: IP increases as the temperature goes up because the resistance goes down. After aging, the increase in value should be within 5% of the Standard Value. Example: before aging value \rightarrow 37-38mA., suitable value after aging \rightarrow 40mA.

If the IP rapidly increases, the Photo Diode has a problem. In this case, the Optical Pickup needs replacing.

Adjust the RF Level to 1Vp-p using the trimmer potentiometer and make sure that the IP is in the specified range.

Apply 1-hour aging to the unit and make sure again that the IP is still in the specified range.
