<b>ONKYO.</b>		<b>SERVICE BULLETIN NO:03007</b>	
MANAGER Kiyoshi Matsuoka	GL Seiji Ichikami	DESIGN Terukazu Matumi	
2003/07/25	2003/07/25	2003/07/25	
MODELS : DTA-9.4			
SUBJECT : Improvement of the sensitivity of DC detection circuit

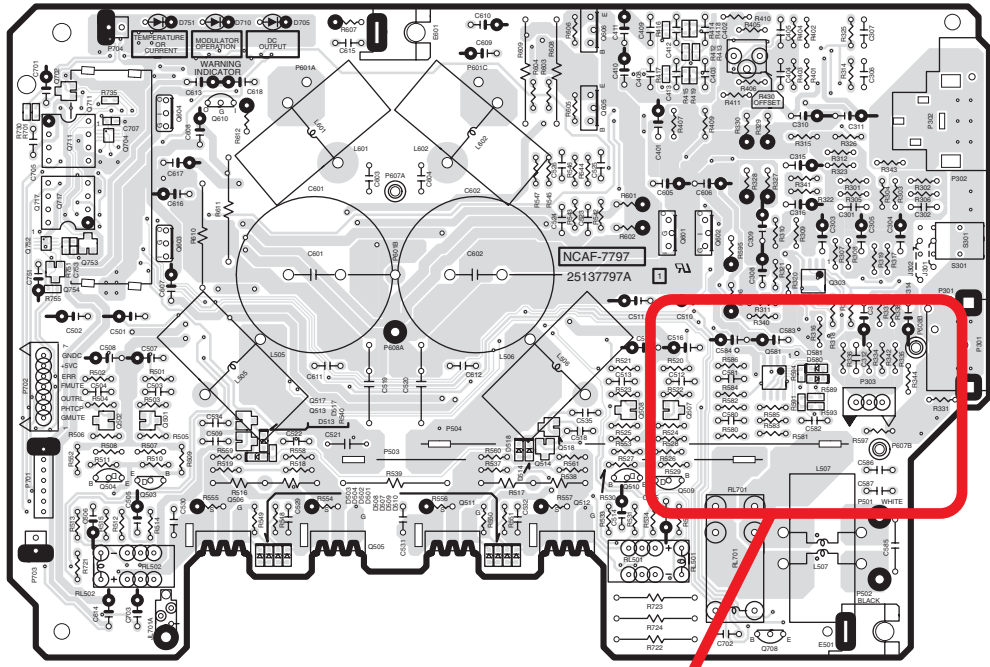
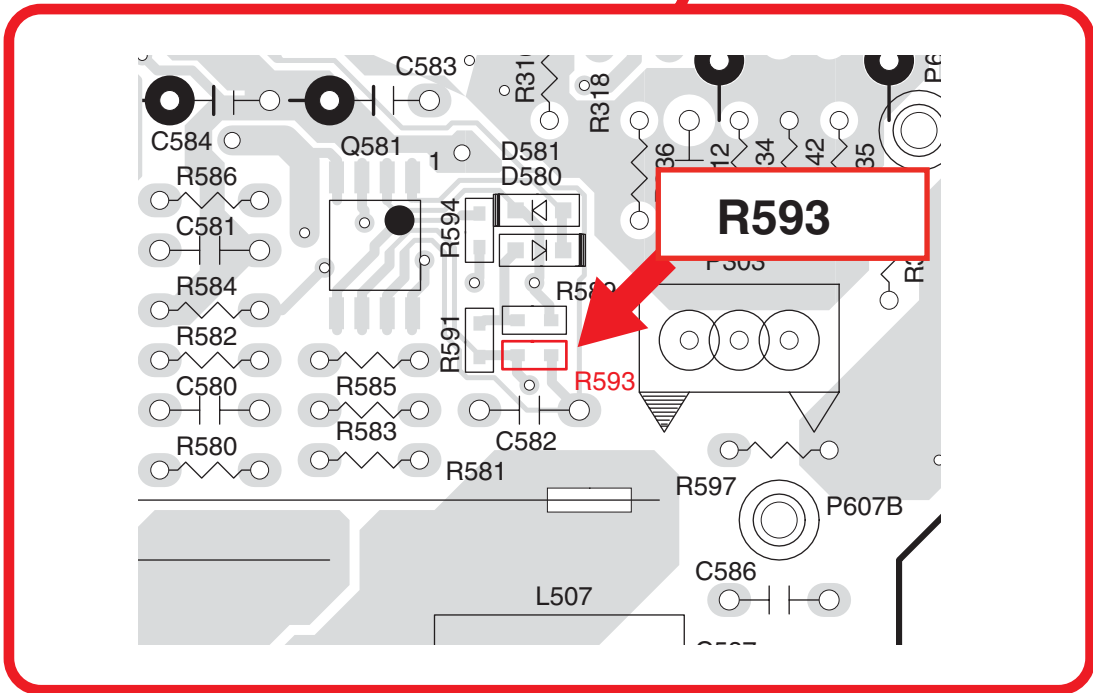
**U15** POWER AMPLIFIER PC BOARD  
(NAAF-7797)  
Component side

When an excessive signal is inputted into amplifier, DC detection circuit operates and results No sound.

The DC current detection circuit is too sensitive.

In NAAF-7797 R593, chip resistor is changed from 10K to 3.3K

DAT-9.4 has seven units of NAAF-7797 and do this change for all units.
