ONKYO.		SERVICE BULLETIN NO:03007	
MANAGER Kiyoshi Matsuoka	GL Seiji Ichikami	DESIGN Terukazu Matumi	
2003/07/25	2003/07/25	2003/07/25	
MODELS : DTA-9.4			
SUBJECT : Improvement of the sensitivity of DC detection circuit

SERVICE BULLETIN
NO:03007

U15 POWER AMPLIFIER PC BOARD
(NAAF-7797)

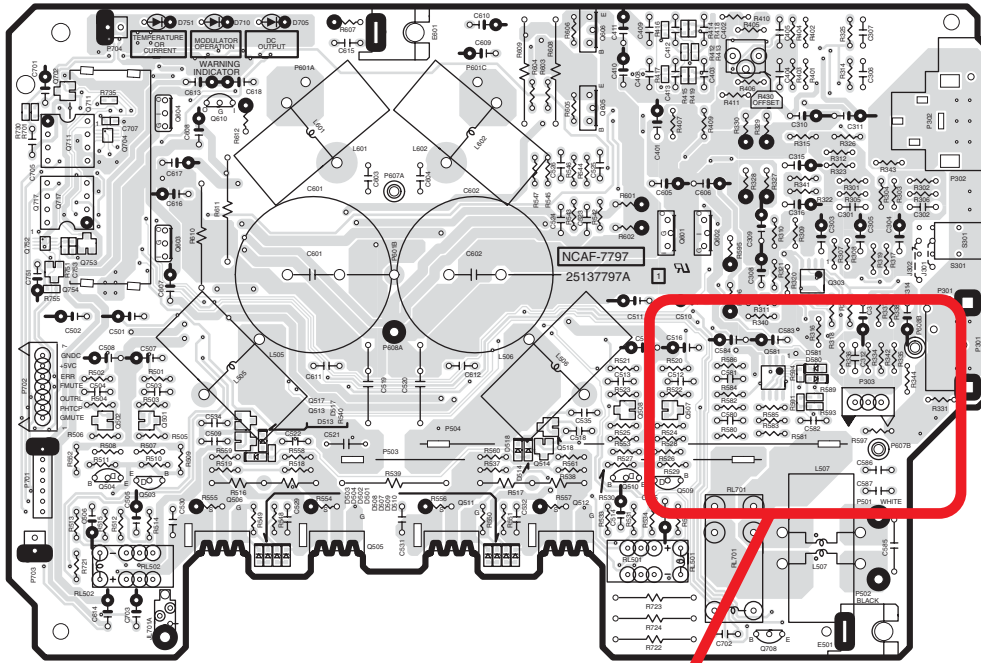
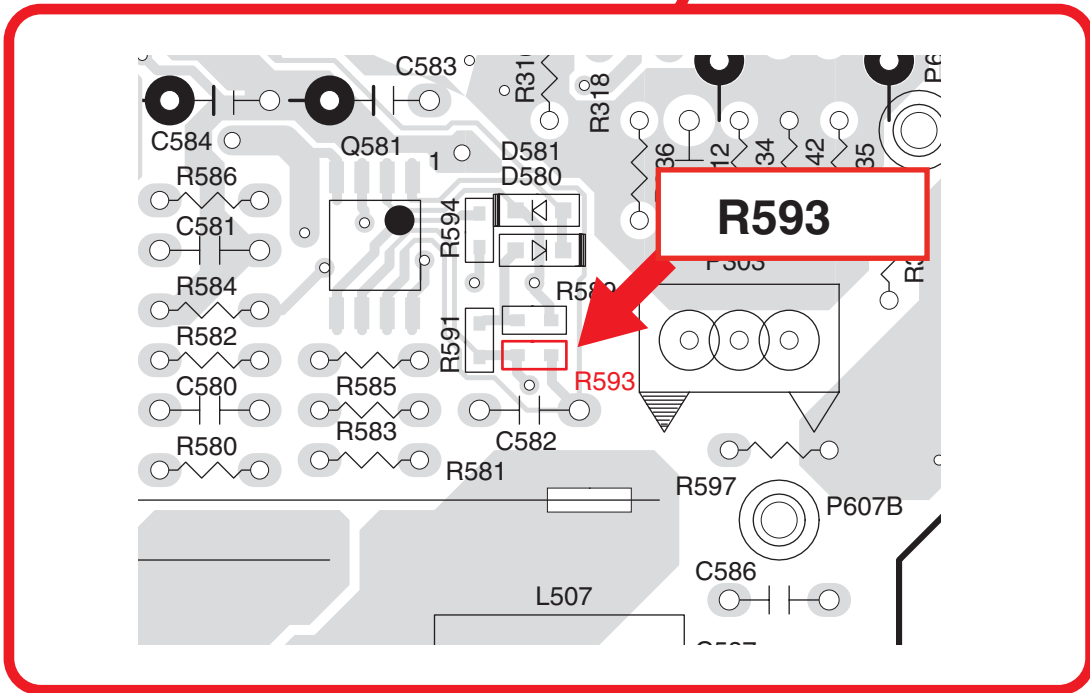
When an excessive signal is inputted into amplifier, DC detection circuit operates and results No sound.

The DC current detection circuit is too sensitive.

In NAAF-7797 R593, chip resistor is changed from 10K to 3.3K

DAT-9.4 has seven units of NAAF-7797 and do this change for all units.
