Tips & Tricks

No. 20060906

Model: DTR4.6 / 5.6 /6.6/7.6 TX-SR573/TX-SR603X

Subject: XM ANT Jack

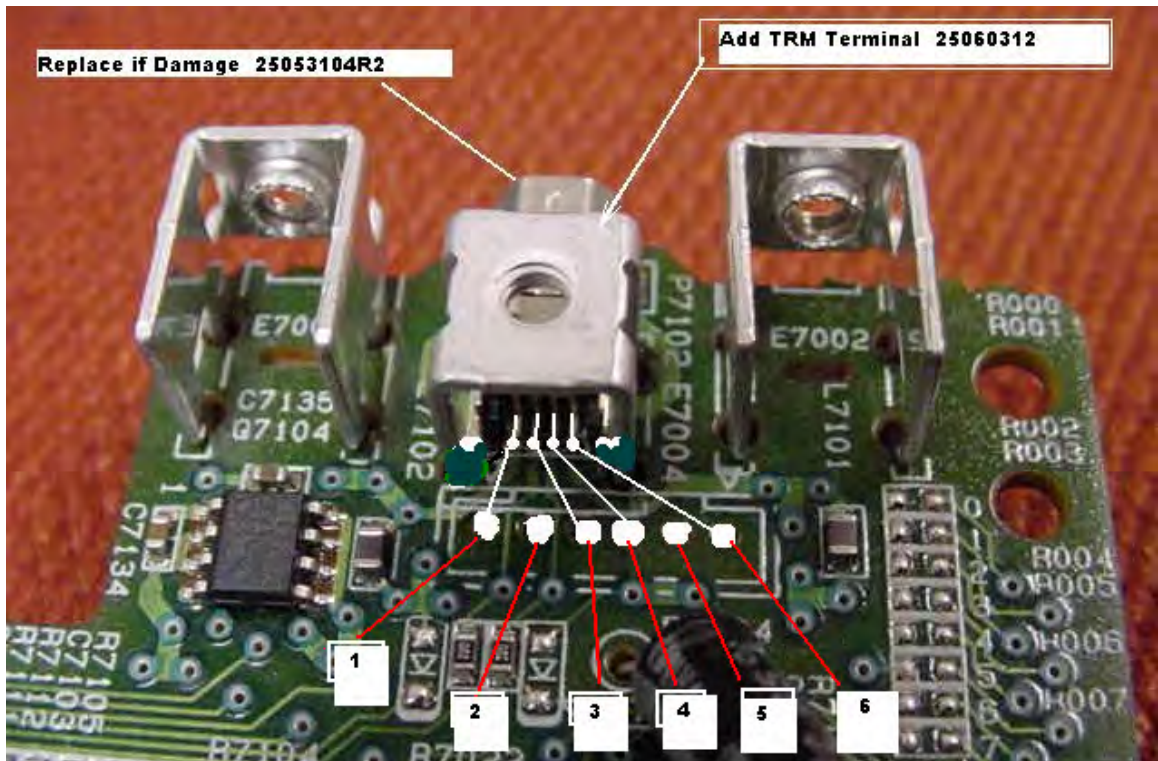
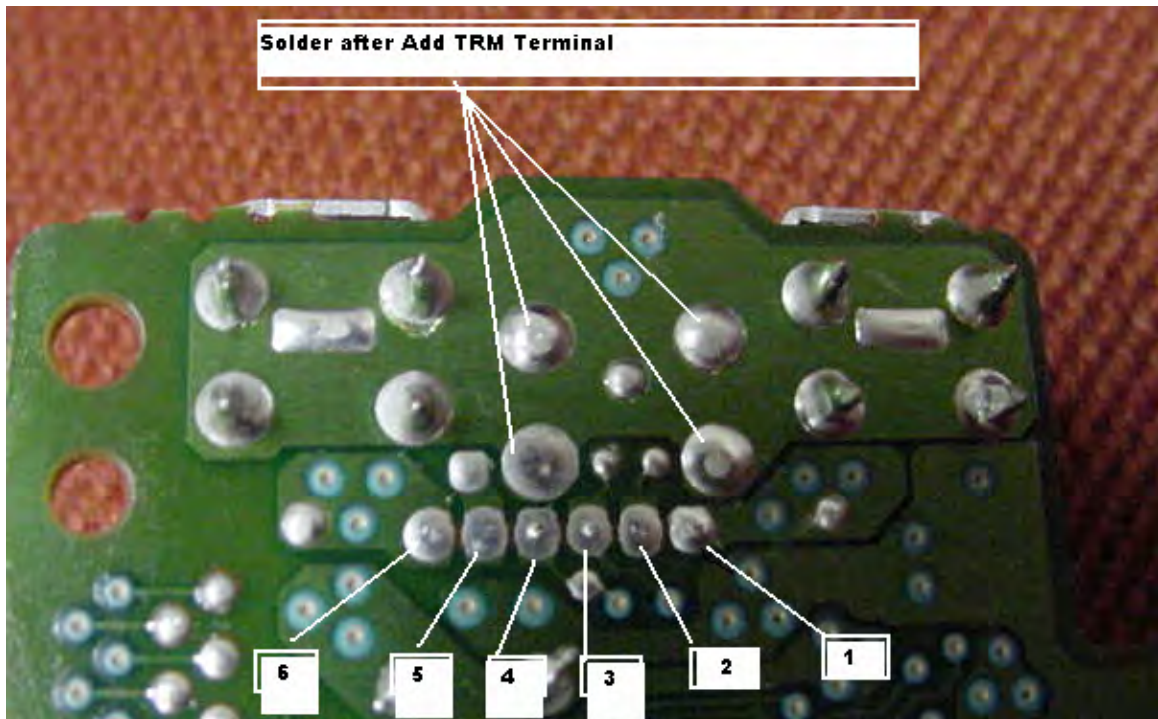
Symptom: XM ANT JACK broken lose from PCB board.

Solution: ADD TRM Terminal support hold Xm Satellite ANT Jack mounting on board. Solder jump wires for connection see next page two pictures.
