Title: DTR-9.1

Application: Service Tip

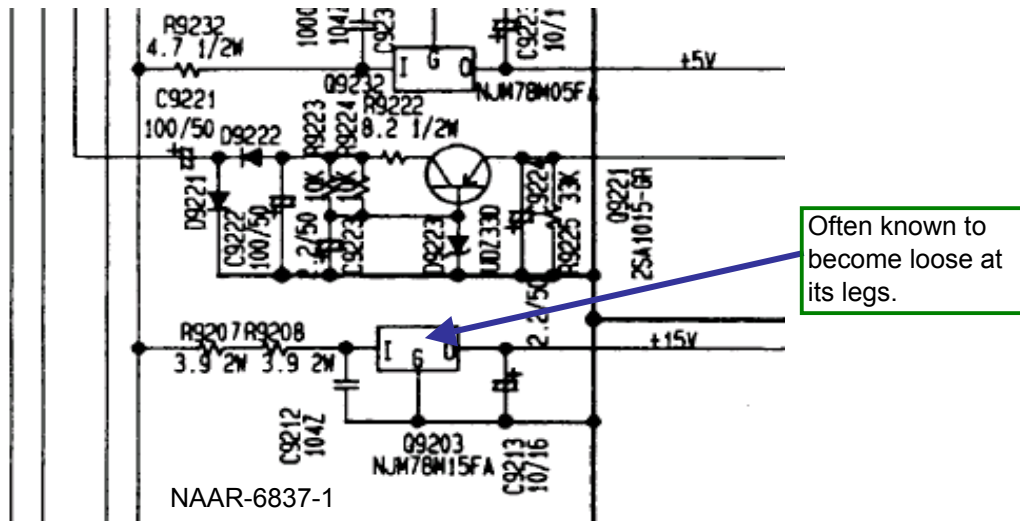
Main Micro-processor Section

Do to aging an environment (warm) in which a unit may be working, some units may experience power supply failure as a result of cold solder point around Q9203 legs on Main Micro Processor PCB (NAAR-6837-1), Q9302, Q9322, Q9304 and 9303 on Power supply regulator PCB.

A loose connection at Q9203 is known to cause Poor Video, Distorted Audio and malfunction of Q817, Q820 having direct relation to the DSP master clock error.
