## Technical Tip

**Model:** HTR-330/530, TX-SR303/SR503

**Subject:** General troubleshooting for Protect problem.

## Service Bulletin

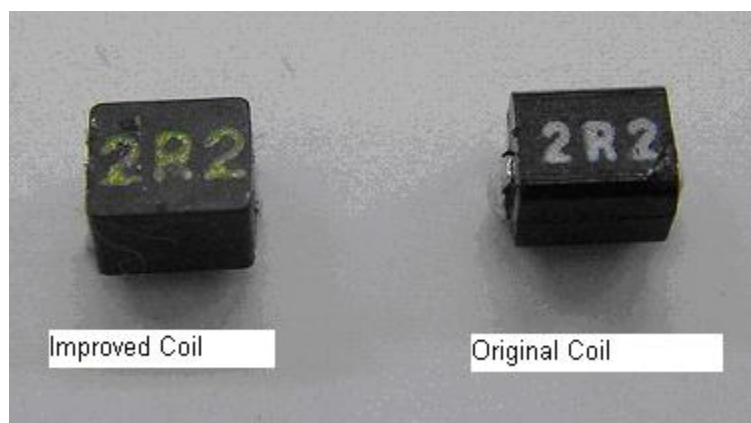
**Symptom:** No sound in Surround mode. Coil L921 which is located on the DSP board may have opened due to in rush current.

**Solution:** Check coil L921, if open, replace L921 with the improved part (green print).
