SERVICE BULLETIN
NO:99010-r1

MODELS : TX-DS575

SUBJECT : Noise is heard from "VOLUME MIN" to "VOLUME 1".

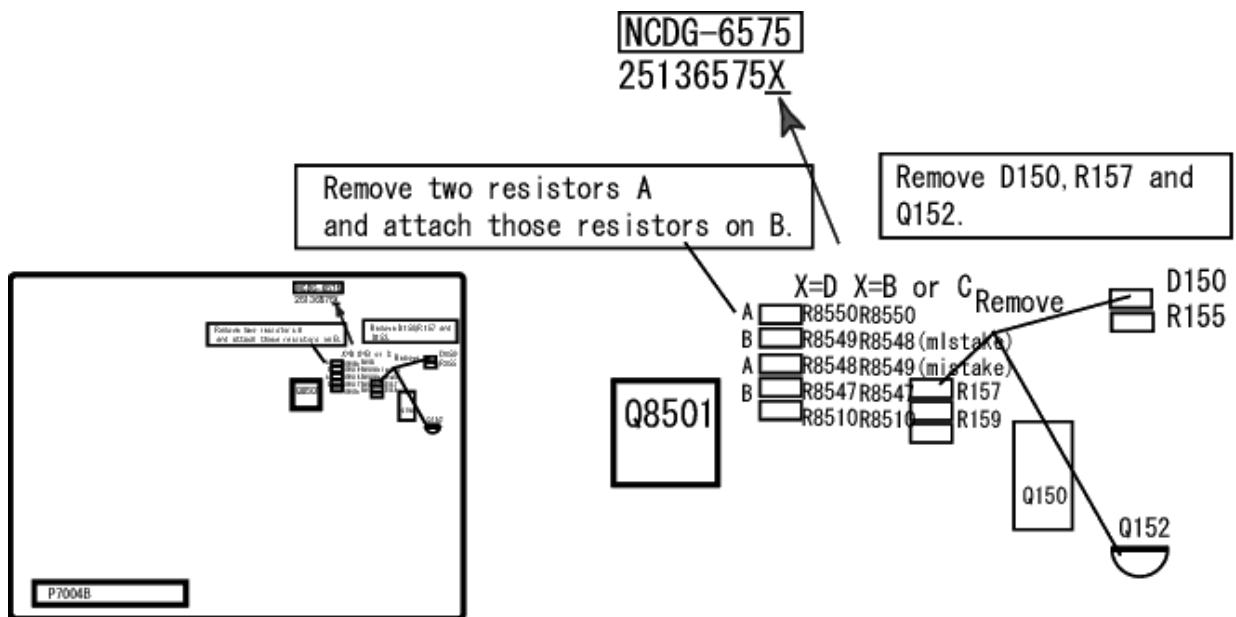
Note: When you change the microprocessor from 045-3BA to 047-3BA, remove 2nd PLL circuit and change the setting of A/D,D/A Converter IC Q8501.

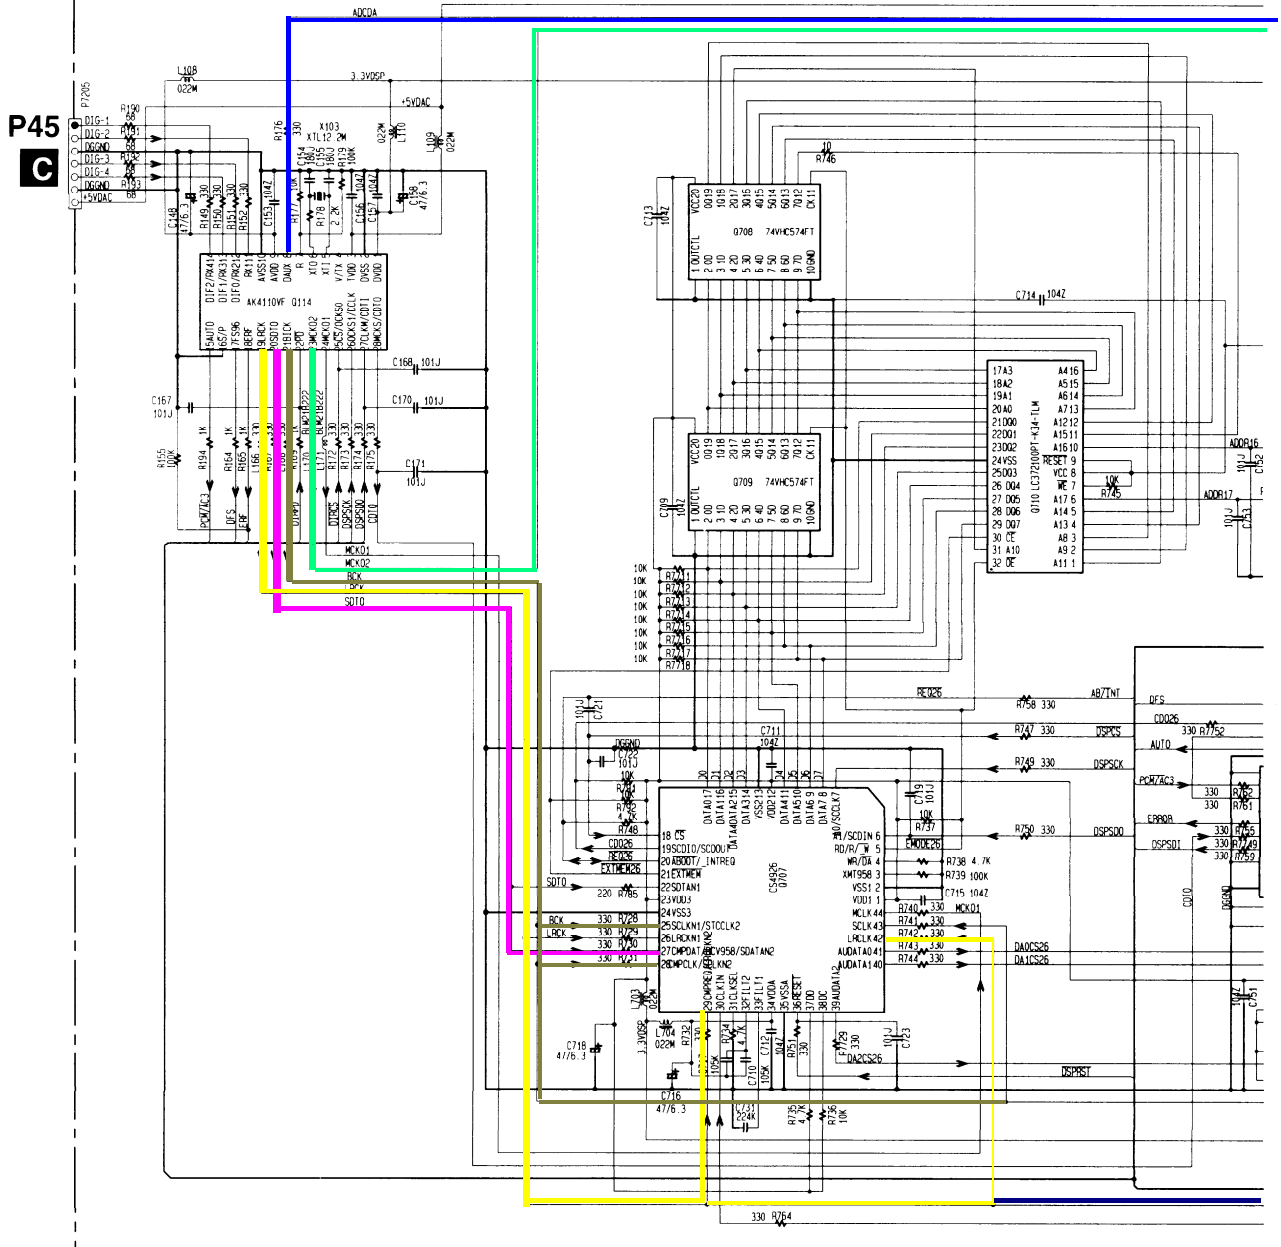
Audio Data from Q8501 Pin 9 arrives at Pin 8 of Q114.

Same data will find its way out at pin 20 of Q114.

It is important X0-XI Pin 5, and Pin 6 work correct and that 12.2Mhz oscillation is present. No noticable drift or Jitter should be noticed.

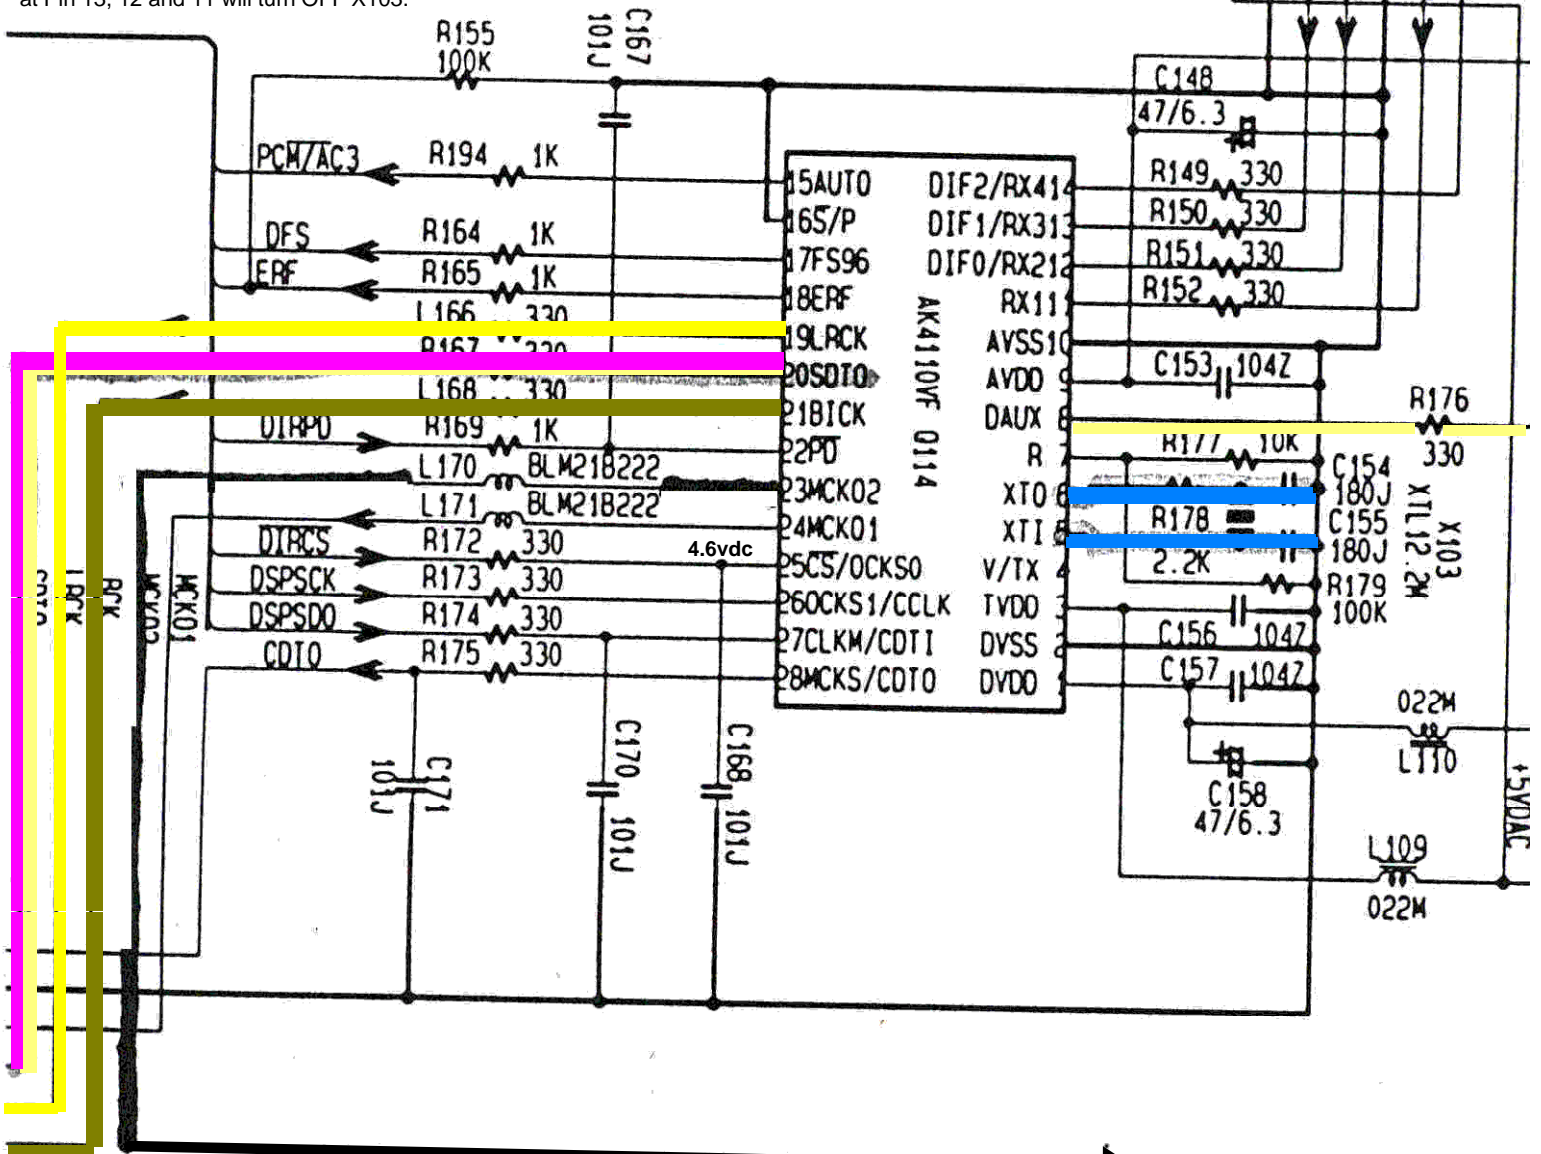
Analog Digital

Q114 Pin 15 = L → =H

Q114 Pin 17 = H → =L

It is conditional that audio data is present at Pin 8 (DAUX) of Q114 and that X-tal X103 is ON in-order for Q114 to operate properly. The digital condition set forth at Pin 15 and 17 along a presence of digital data at Pin 13, 12 and 11 will turn OFF X103.
