SERVICE BULLETIN NO:00007

MODELS: TX-DS989

SUBJECT: The sound of fan is large.

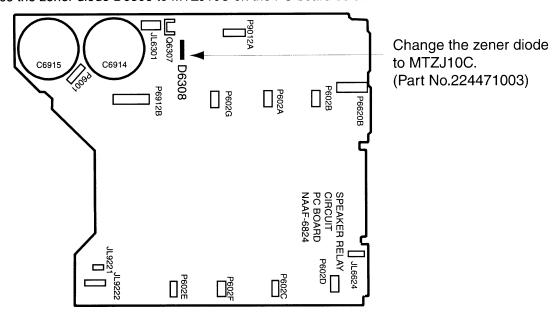
Symptom: The rotation sound of the fan is large.

Counter-measure: The drive voltage of the fan is decreased from 13V to 10V so that the operation sound when rotating is decreased.

- 1. Remove the top cover.
- 2. Remove the screws holding PC boards except the fan, the component video PC board, and the tuner unit on the rear panel.
- 3. Cut the binder A of the left side on the bracket PT.
- 4. Remove a screw B.
- 5. Remove a screw C holding the holder D and remove it.
- 6. Remove the five screws E holding PC board G and remove the four screws F. Lift up Power Amplifier assembly H. D6308 Tuner unit Component video PC board Rear panel С Fan

Replace the zener diode D6308 to MTZJ10C on the PC board below.
