**Title:** TX-DS989

**Application:** Service Tip

**Symptom:** No audio, Intermittent shut down, poor reproduction, poor video and vary distorted audio.

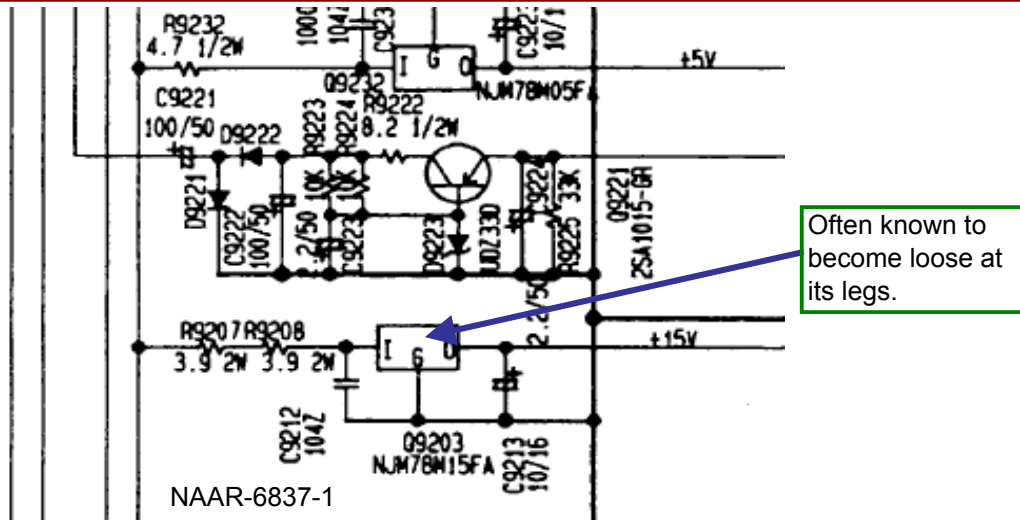
Main Micro-processor Section

Do to aging an environment (warm) in which a unit may be working, some units may experience power supply failure as a result of cold solder point around Q9203 legs on Main Micro Processor PCB (NAAR-6837-1), Q9302, Q9322, Q9304 and 9303 on Power supply regulator PCB.

A loose connection at Q9203 is known to cause Poor Video, Distorted Audio and malfunction of Q817, Q820 having direct relation to the DSP master clock error.

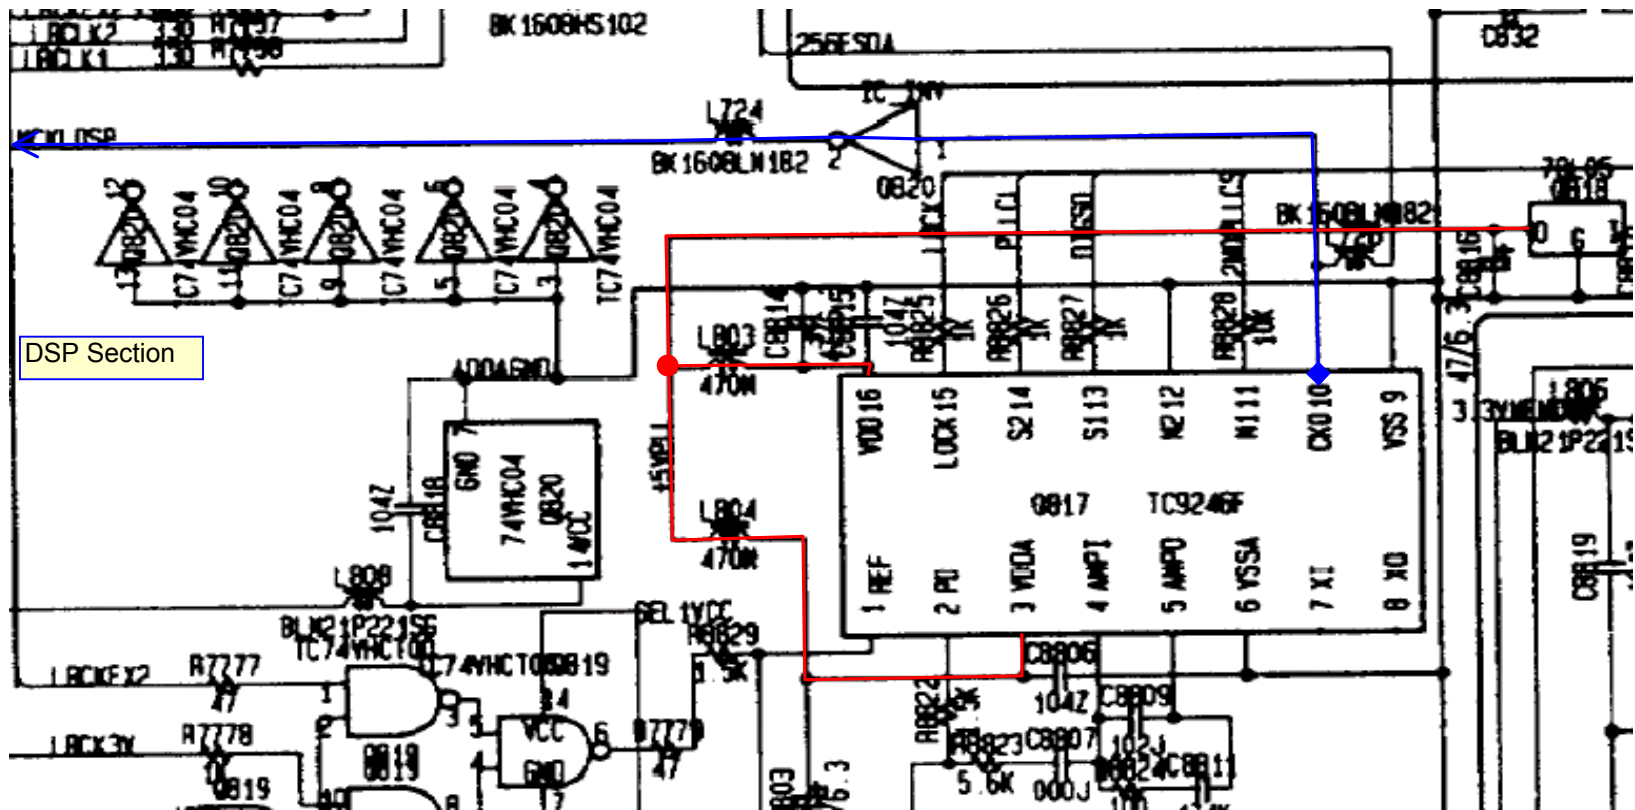
DSP Section

The failure of this section of the DSP is very critical and that the reproduction experience as stated by a consumer can differ from one customer to the next. Therefore it is very important that one makes all the appropriate touchups on all regulator components and inter connecting wires in the case of NCPS-6839 and NCPS-6838 power supply PCB's.
