Ref #: SR500LFE-01-VID

Title: TX-SR500B

Classification: Mandatory Service Bulletin

Ref: TR500-SR500-VID

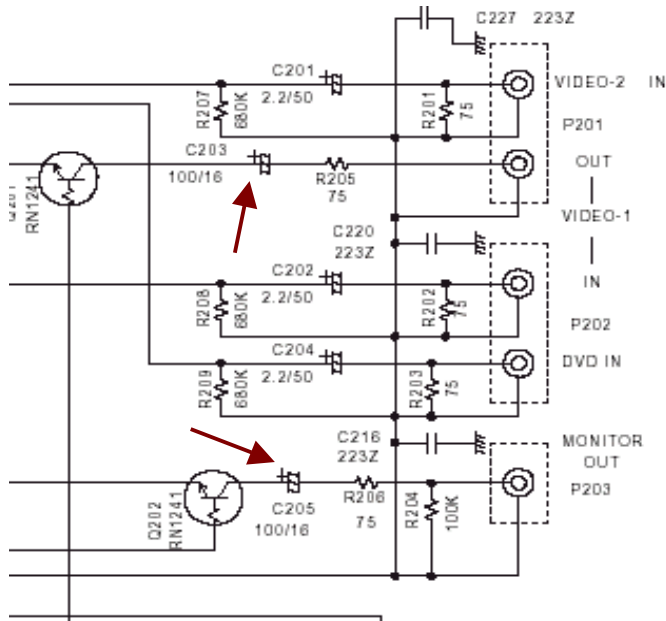
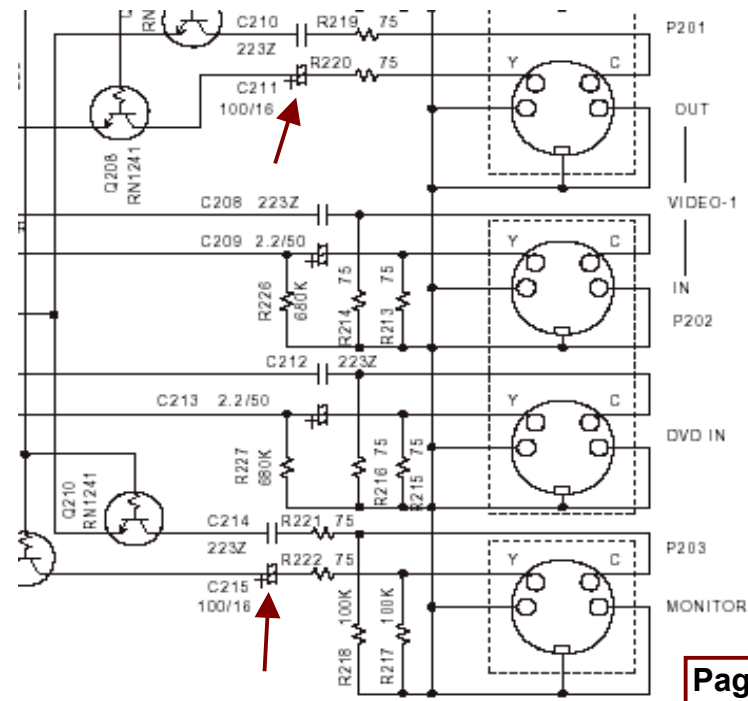
Problem: In some rare occasions, some TV-Monitors may experience Video Mute, Unusable Signal and Vertical Jumping video conditions when S-Video and Video is sent through receiver.

Solution: Replace C203, C205, C211, and C215 with 1000uf 6.3v capacitors. Part Number 354721029.

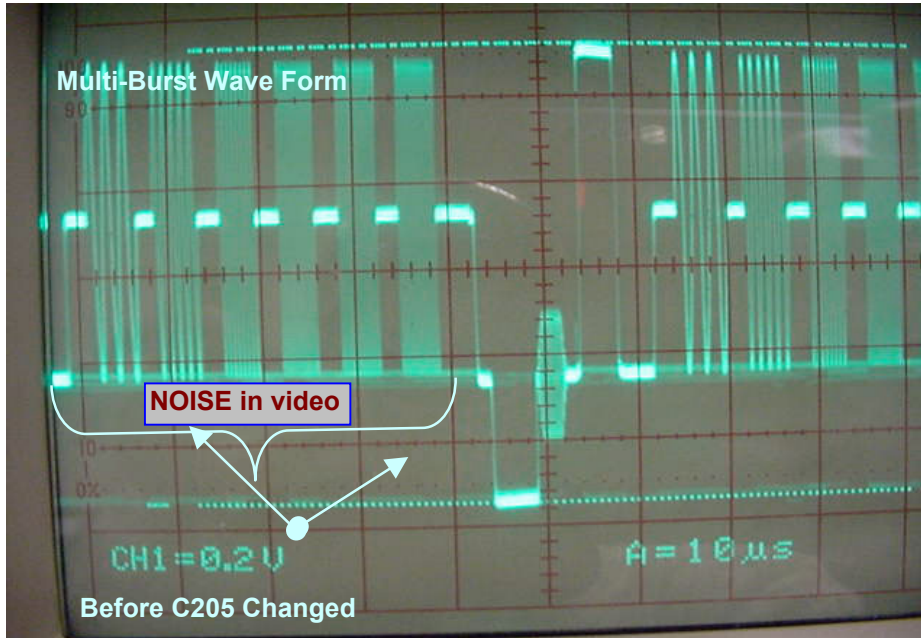
HT-R500 and TX-SR500 Disclosed information is only based on Composite Monitor Output. The change and modification will also apply to the S-Video Monitor Output as well.

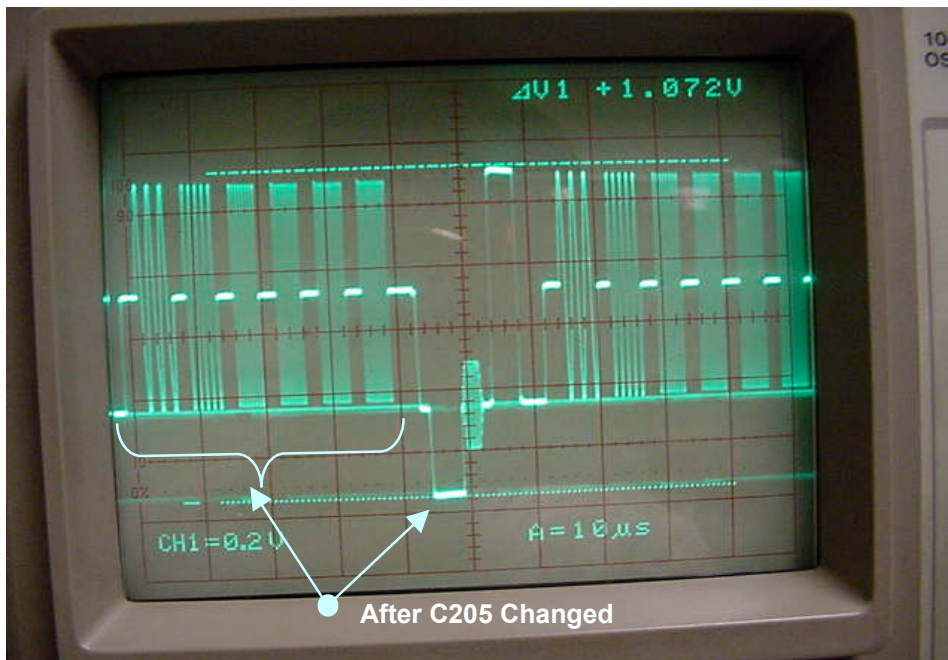
In HT-R500 a change in C205 from its current value 100uf16V capacitor to 1000/6.3V will help eliminate the ringing and jitter in video waveform.
