Technical Tip

Date: April 6, 2006

Model: TX-SR803/SR703, DTR-4.6/5.6/6.6/7.6

Subject: High pitched noise is heard in the subwoofer.

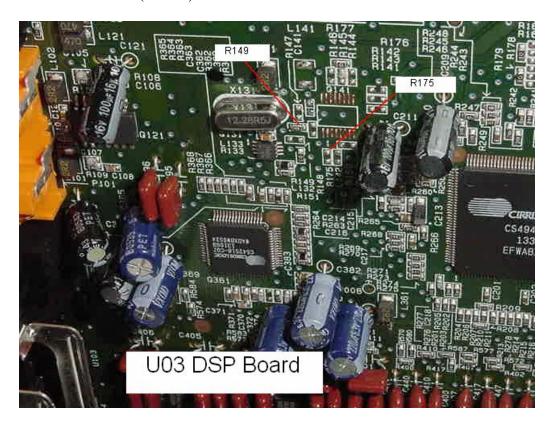
Symptom: A high pitched noise or, a motorboat noise can be heard when using the Optical, Coaxial or HDMI input.

Solution: If the DSP board (U03) is marked NADG-8660-1 (see board version pictures) modify the DSP board as follows: Relocate resistor R175 (470hm) to location R149.

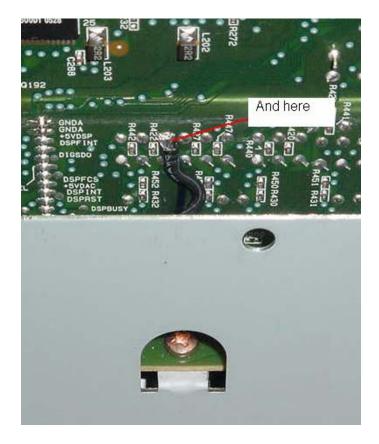
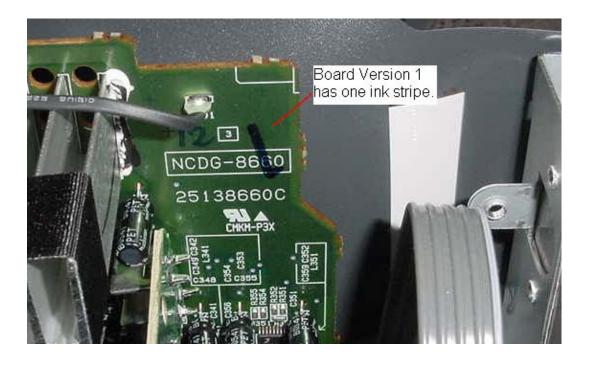
Board version 1 can be identified by the ink stripe marking. One line indicates the board is version one.

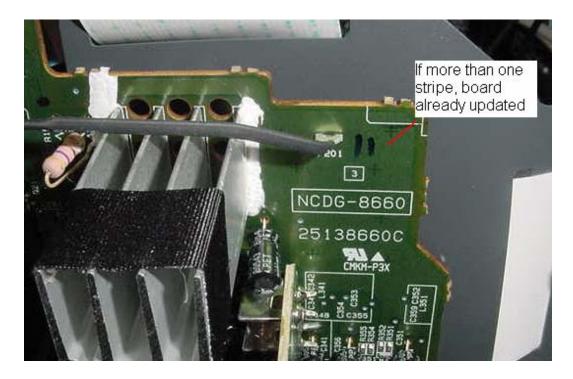
Two or more lines indicate a later revision board.

Note: On later revision boards, R175 is a zero ohm resistor and R149 already has a 47 ohm resistor mounted on the board. In this case, you just need to add the jumper wire.
