Technical Tip

Model: DTR-4.6/5.6/6.6/7.6

Subject: Remote and Wired remote does not respond well to input commands

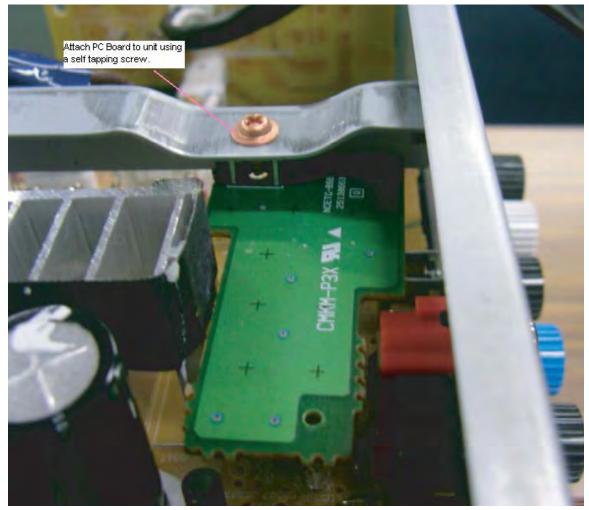
Symptom: When using remote or an external IR controller connected to the rear panel IR input the set may not respond properly to IR commands.

Solution: Install the IR Shield PC Board as described. Cover the IR Remote Sensor.

- 1.) Solder the Terminal Connector to the PC board.
- 2.) Attach the PCB you assembled to the set using a self tapping screw.
