SERVICE INFORMATION

Ref. No. 9708
Date Aug. 5, '97

MODEL	TX-SV444
ITEM	Changes of circuit

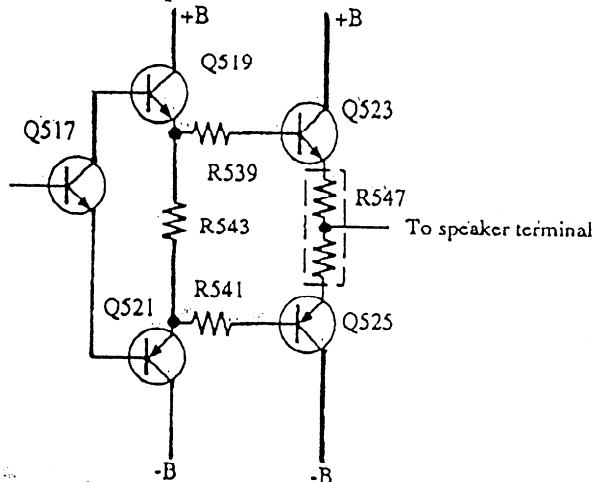
Symptom: No sound

Cause: The abnormal idling current flows according to the error tolerance of parts or the attachment position of thermal compensation transistors, and the power transistors, resistors etc. are broken.

Countermeasure: The parts below were changed to decrease the idling current.

1. Check all parts as shown below.
