Quick Service Manual

Ref. No.: HA-97-195

"Error" Indication in Disc Search

Mechanism jamming problem

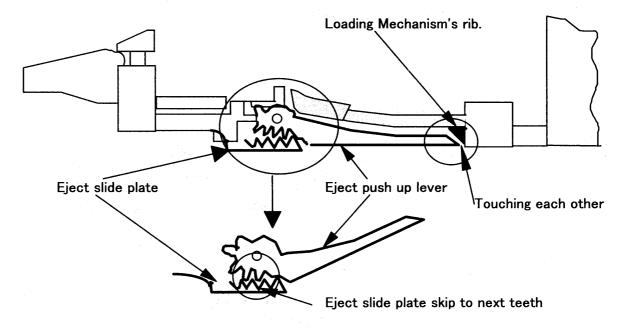
- 1) When the Eject Lever was pressed, while eject Lever position was same number with play position (example : 10 slot), it will touch to Loading Mechanism's rib.
- 2) Then if the Eject Lever was pressed more strongly, The gear of Eject slide plate will be skip to next teeth.
- 3) Usualy the Eject side lever will be go back to initial position by spring, but in this case it doesn't go back to initial position for gear sticky. So Eject Lever will stay upper position.

As a result, Loading Mechanism movement is disturbed.

- 1) Change eject push up lever Ass'y from old type (RFKNLMC50PEK) to new type (RFKNCH64MP-K).
- 2) Change eject slide plate from old type (RML0439) to new type (RML0439-1)

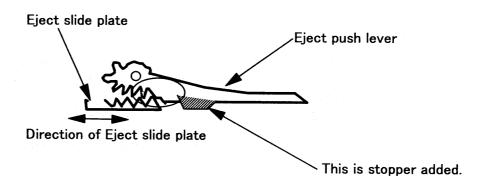
1) Eject push lever add material. (change shape)

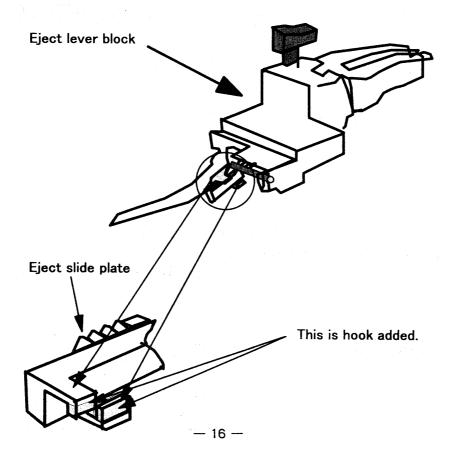
2) Eject slide plate
