| Hi-Fi<br>Audio | <b>Quick Service Manual</b> | | Ref. No.: HA-97-195 |

**Subject:** "Error" Indication in Disc Search

| Hi-Fi<br>Audio | <b>Quick Service Manual</b> | | Ref. No.: HA-97-196 |

**Subject :** Mechanism jamming problem

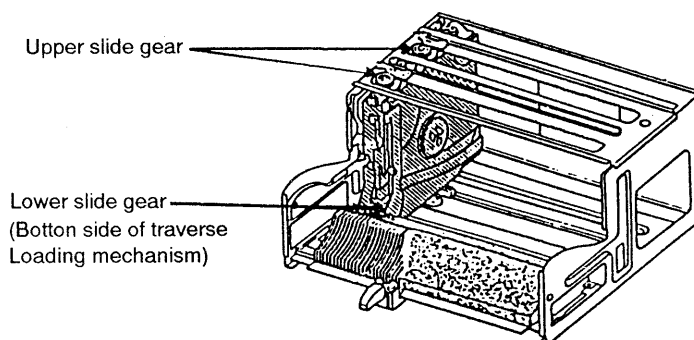
**Symptom:** "Error" Indication after Disc Search mode.

**Cause:** The teeth of slide gear is shifted due to vibration or/and shock in transportation.

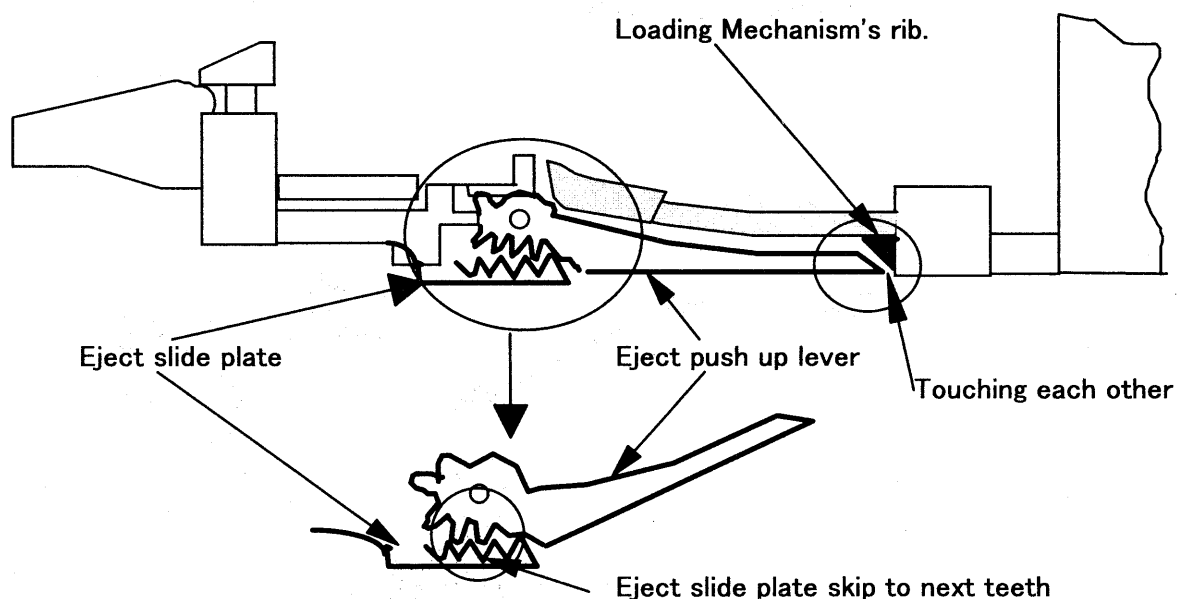
**Symptom :** Traverse Loading Mechanism doesn't move at all.

- 1) When the Eject Lever was pressed, while eject Lever position was same number with play position ( example : 10 slot ), it will touch to Loading Mechanism's rib.
- 2) Then if the Eject Lever was pressed more strongly, The gear of Eject slide plate will be skip to next teeth.
- 3) Usually the Eject side lever will be go back to initial position by spring, but in this case it doesn't go back to initial position for gear sticky. So Eject Lever will stay upper position.  
As a result, Loading Mechanism movement is disturbed.

- 1) Change eject push up lever Ass'y from old type (RFKNLMC50PEK) to new type (RFKNCH64MP-K).
- 2) Change eject slide plate from old type (RML0439) to new type (RML0439-1)
