**Model:** SL-CH9

**Subject:** Malfunction of Detection Switch

**Subject:** Malfunction of tray closure detection switch

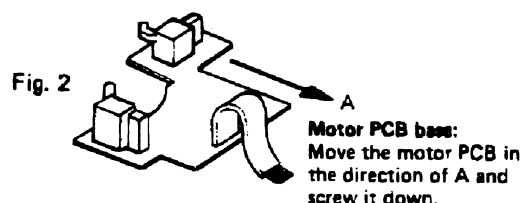
Fig. 1

**Cause:** Because the clearance of the loading base is uneven, the thrust of the close detection switch (S101) by the rack gear is insufficient when the tray is closed. This causes the switch to turn off after it has been turned on (the closure is detected).  
This problem tends to occur when the loading base that has a 5 of 6 stamped on its back, as shown in Fig. 1.

When installing the motor PCB, as shown in Fig. 2, move it in the direction of A and screw it down. Or attach a 0.2 mm sheet (RMQ0134) to the oblique-line portion of the tray switch (see Fig. 3).
