# PSU Modification A30.2

070212

This modification solves a stability problem with the power regulation for the amplifiers driverstage.

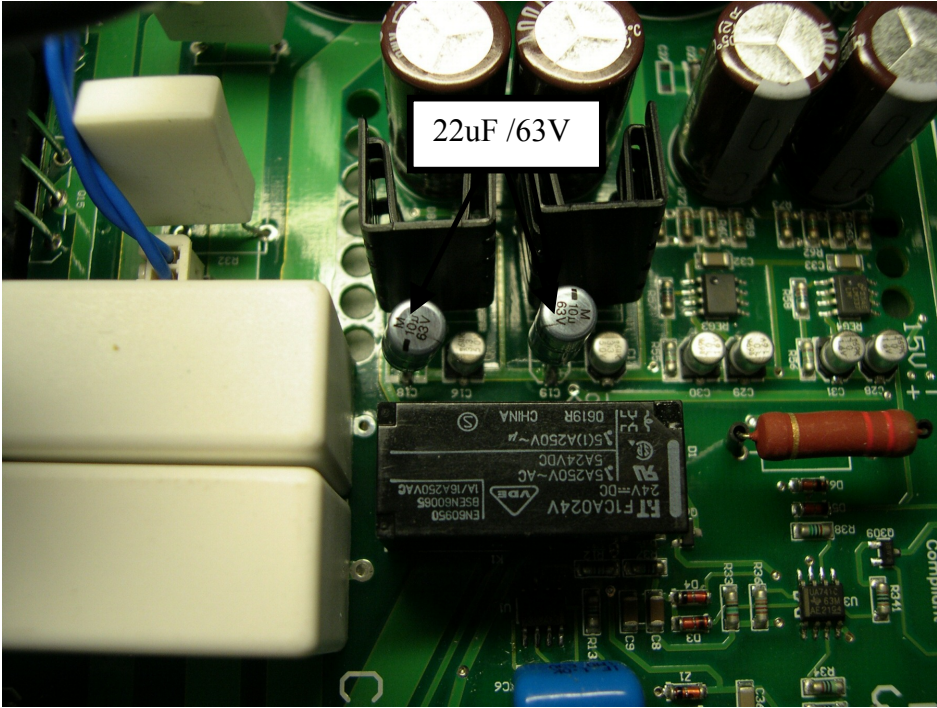
**Left CH**

**Note!** I have used 10uF capacitors in these pictures, the correct value is 22uF.

1. Remove mains power and the topcover.
2. Remove the heatsinks on REG1, REG101, REG2, REG102 in order to free up space for the soldering iron.
3. Solder 22uF/63V 105 centigrades capacitor in parallel with C18, C118, C19, C119 (or replace the original 3.3uF capacitor). Use a small soldering tip when carrying out this work and watch the relays !
4. Put back the heatsinks on REG1, REG101, REG2, REG102.
5. Test the amplifier and measure the voltage at +-48V test points on both channels.
