SERVICE BULLETIN

UNIT IN QUESTION: **TTM 56**
AREA CONCERNED: No Contact Magnetic Fader.
(Field inspection and maintenance.)

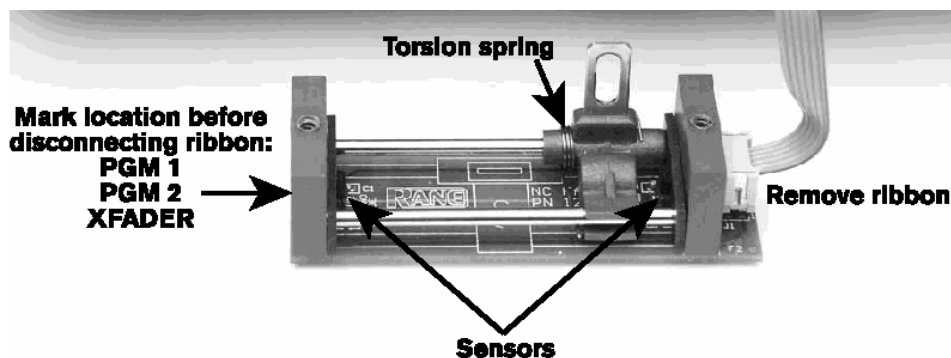
Pictured below are the two sensors, support rods and carrier. The most important item to confirm is the proximity of the hall sensors to the carrier. The correct distance is about the same thickness as the PCB — minimum 0.062". If the distance is too great (i.e. the sensor has been pushed away from the center of the fader, which commonly happens during cleaning and lubrication, the symptom is typically “bleeds” with slow contour, and failure to turn off with fast contour. This is due to the magnet not coming close enough to the sensor for maximum attenuation. Gently tilt the sensor towards the center of the fader mechanism. Leaning a bit too far inwards is better than the reverse, as it ensures complete turn-off of the fader when using fast contour.

Once the alignment of the sensors has been addressed, clean the two stainless steel rods using a piece of newspaper wrapped around them. Loop the cloth around each rod and polish just as if shining a shoe, but upside down. The newspaper will pick up dust and contaminants from the rods and is easy to use. For stubborn deposits or in situations where the customer has thoroughly contaminated the rods with foreign matter, isopropyl alcohol applied with a Q-tip works well to cleanse the assembly. When all cleaning has been completed a drop of light machine oil should be applied to the support rod only (**not** the one the torsion-spring rubs against.) Just about any oil with a viscosity of 20W will work, but we recommend pure silicone lubricant. Rane does not provide lubricants or cleaners.
