Subject: **OSCILLATION ON DATA LINES WHEN
 USING 74HC244 DATA BUFFERS**

Model: **APR-24**

Serial No: **10,001-10,122**

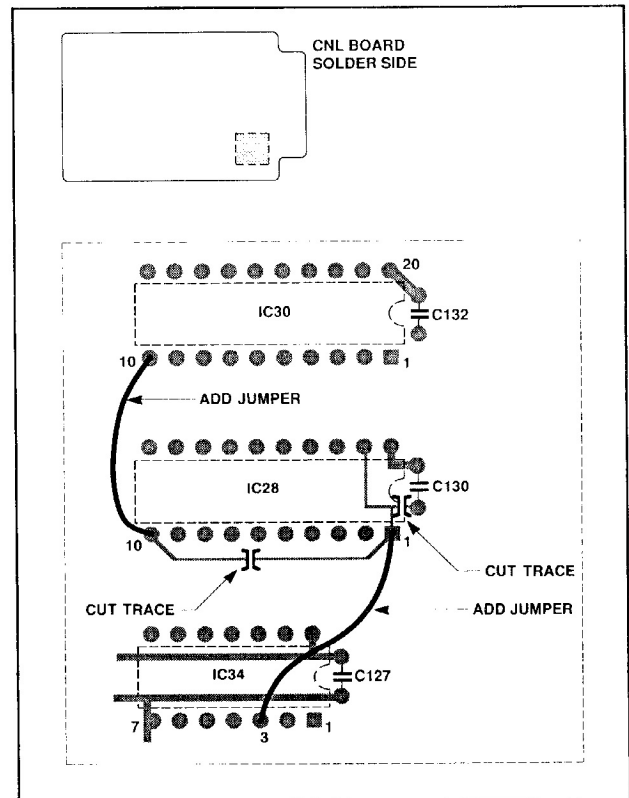
Figure 1

Oscillation may occur on the CNL data lines due to an instability caused by the multiple feedback loops provided by the data lines, the buffers, and their interconnecting power lines.

To correct this problem, change the addressing of CNL IC28 (74HC244) from "continuous" to "selected" by modifying each CNL Board as described in the following procedure.

Solder Side (See Figure 1.)

1. Cut trace between IC28-1 and IC28-10.
2. Cut trace between IC28-1 and C130.
3. Add jumper between IC28-10 and IC30-10.
4. Add jumper between IC28-1 and IC34-3.
5. Secure both jumpers with SONY Bond SC-108.
