Professional Audio Products Technical Bulletin 89–039

Date: May, 1989

Model: APR-5002/5003

Subject: REDUCTION OF MASTER ERASE SIGNAL DISTORTION

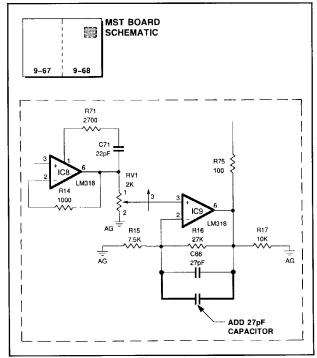
Figure 1

The erase transient at the end of a recorded segment may be too large in APR-5002/5003 units that contain an MST Assembly with part number A-7850-376-B or A-7850-377-B. To correct this problem, perform the modifications described in the following procedure.

MODIFICATION AND ALIGNMENT PROCEDURE MST BOARD (PN A-7850-376-B/377-B) Solder Side (See Figures 1 and 2.)

- 1. Verify that master bias level is 15Vpp.
- 2. Perform record alignments for both channels.
- 3. Load a bulk erased tape into recorder.
- 4. Remove MST Board from unit.
- 5. Solder a 27pF capacitor in parallel with C66.
- 6. Replace MST Board into unit.
- 7. Remove CH1 CNL Board from unit.
- 8. Remove heat sink plate from board.
- 9. Replace CNL Board on card extender.
