Subject: **HIGH FLUTTER WHEN USING "EXT SRC" INPUT**

Model: **APR-5001/5002/5003**

Serial No: **20,201 AND HIGHER (APR-5001)**
20,201 AND HIGHER (APR-5002)
20,401 AND HIGHER (APR-5003)

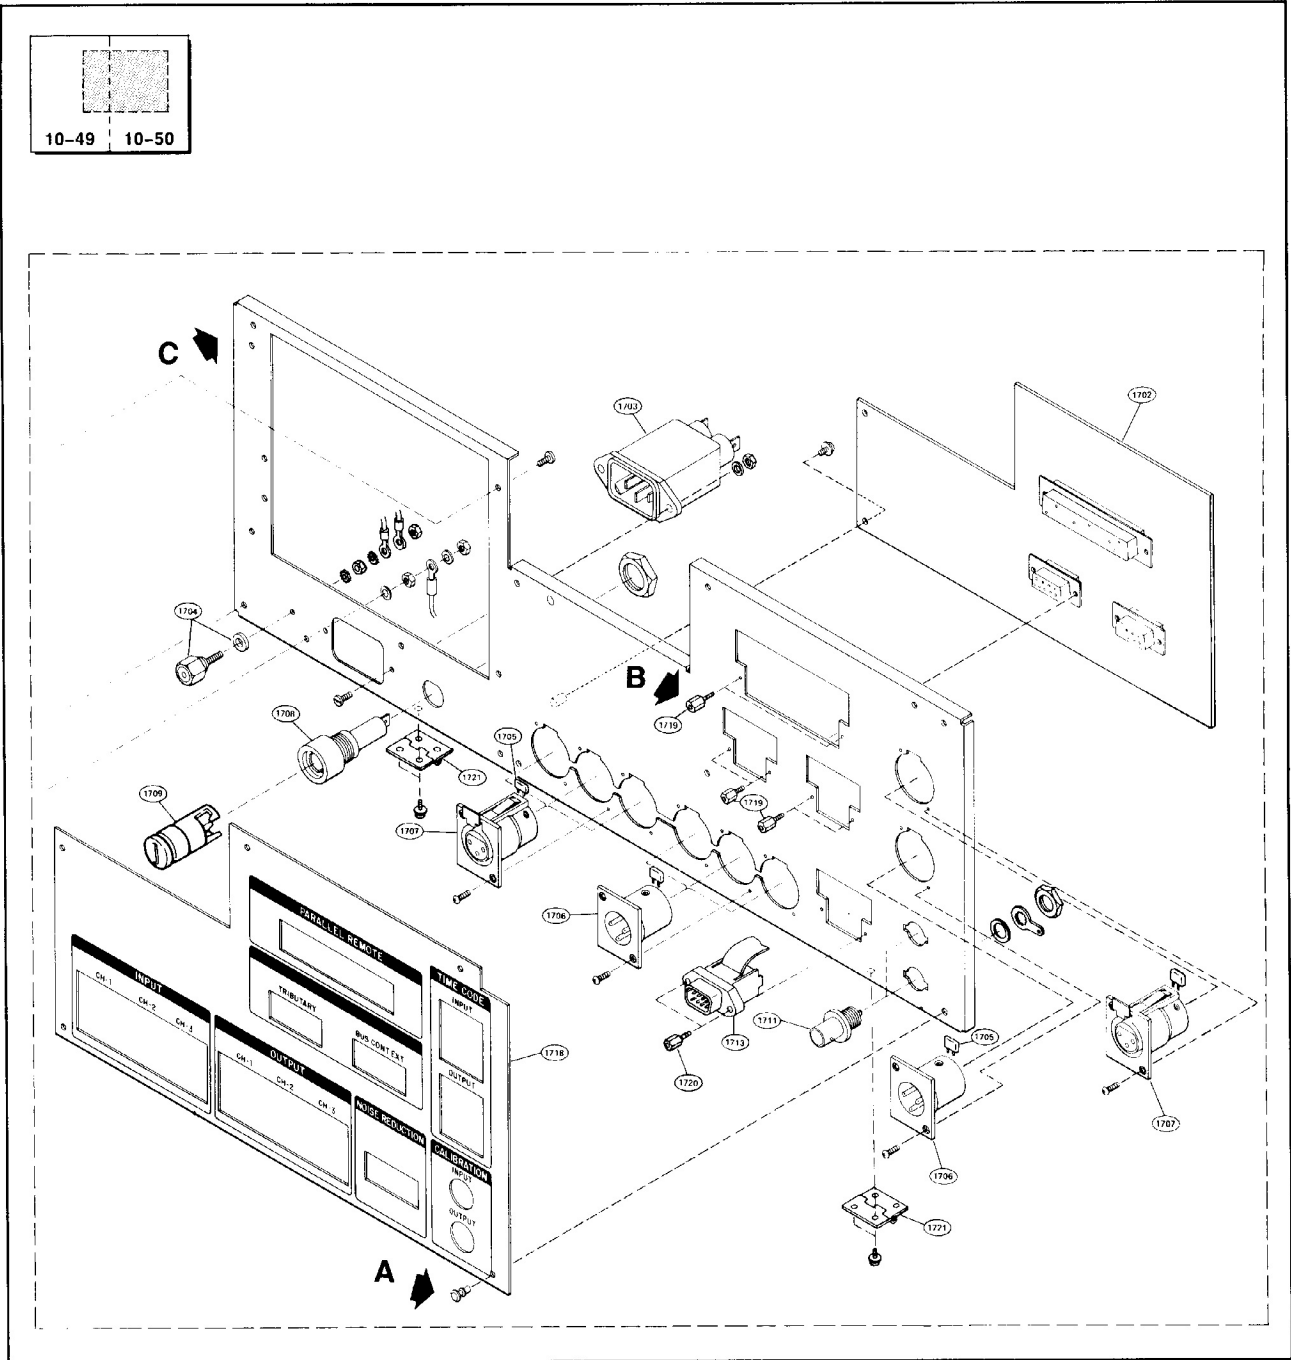
High flutter may occur when using the EXT SRC input. Flutter is caused by a slow rising edge on the output of IC7 on the CNX Board. To correct this problem, modify the CNX Board as described in the following procedure.

1. To access the CNX Board, first remove five pop-in fasteners on rear panel (A).
2. Remove hex screws (6) located on rear panel (B).

3. Open lower rear panel by removing screws (2) located in upper left- and right-hand corners (C). (See Figure 1.)
4. Remove CNX board by first removing screws (2) holding board in place (A). (See Figure 2.)
5. Push connectors out through cutouts so CNX Board can clear lip of outer panel when being lifted out.
6. If CNX board is numbered T-9412-316-1, it will have a 5-pin resistor network (RN1) instead of discrete resistors at R80 and R81. If so, remove IC7 (HCPL-2730) and replace with HCPL-2531 (T-9413-636-1). No resistor changes are needed.
7. If CNX board is numbered T-9412-316-2 through T-9412-316-4, or 1-619-162-11, proceed with steps a and b.
 - a. Remove IC7 (HCPL-2730) and replace with HCPL-2531 (T9413-636-1).
 - b. Remove R80 and R81 (470Ω) and replace with 4.7kΩ resistors.
8. Reinstall CNX Board by repeating steps 1 and 2 in reverse order.
